THE MASONRY WALLS OF FORT WASHINGTON

BY DOUG BOND, PE FOR THE
SOCIETY FOR THE PRESERVATION OF HISTORIC CEMENTS

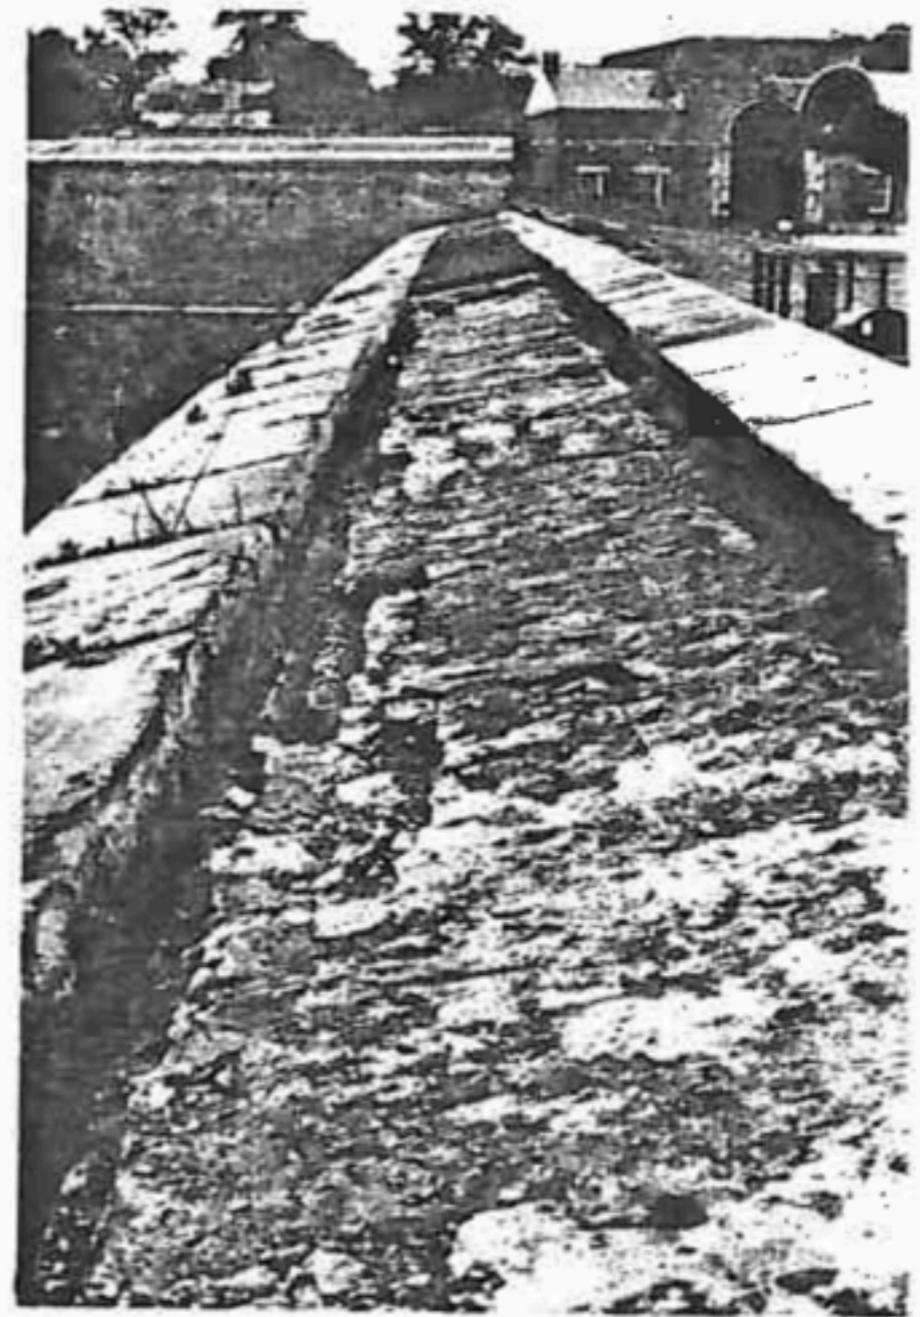
2/8:6/76

- **Bulges in the brick noted Northwest Demi-Bastion**
- **Believed primarily due to Freeze-Thaw**
- **Repairs made to the brickwork on top of the parapet**
- **Recommended repairs included removal of vegetation, pointing, and grouting**

SUPERIOR SLOPE OF THE PARAPET.
Curtain. Brickwork repair in progress.

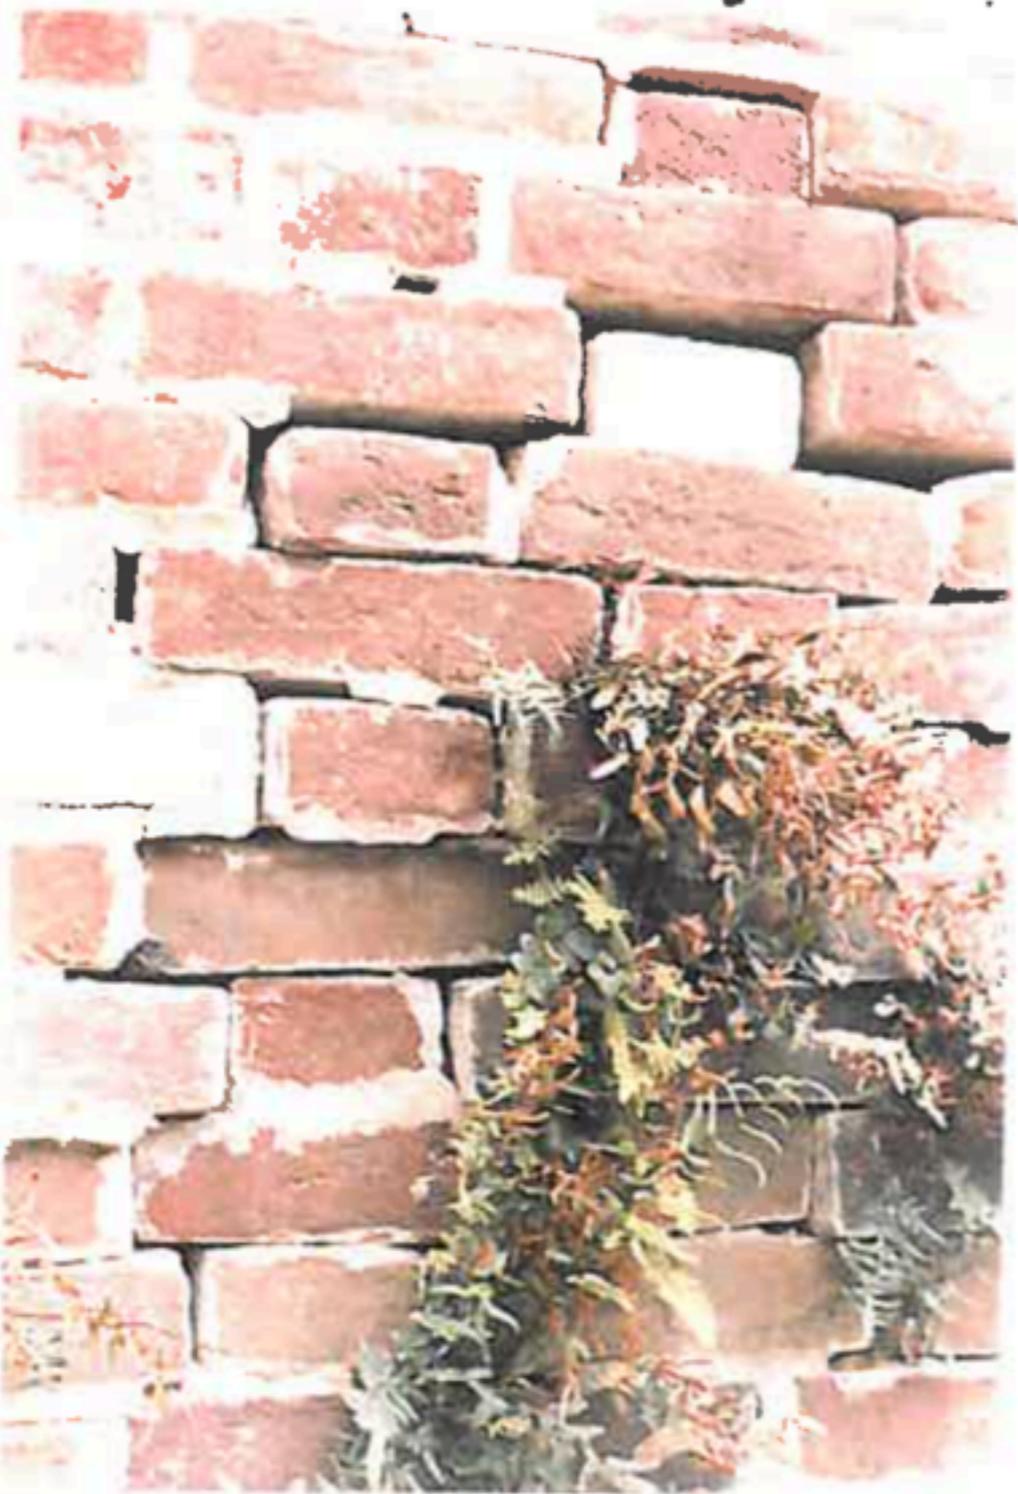
1985 Report

Close up of area of vegetation, the light colored brick & brick below were removed, entire brick structure behind has no sound mortar, only sand with hair remains of original mortar.
