STILL VALLEY RAILROAD TUNNEL

An Unknown Early Cement in Rural NJ

Still Valley Railroad Tunnel

Presented September 18, 2014 at the Fifth American Historic Cements Conference

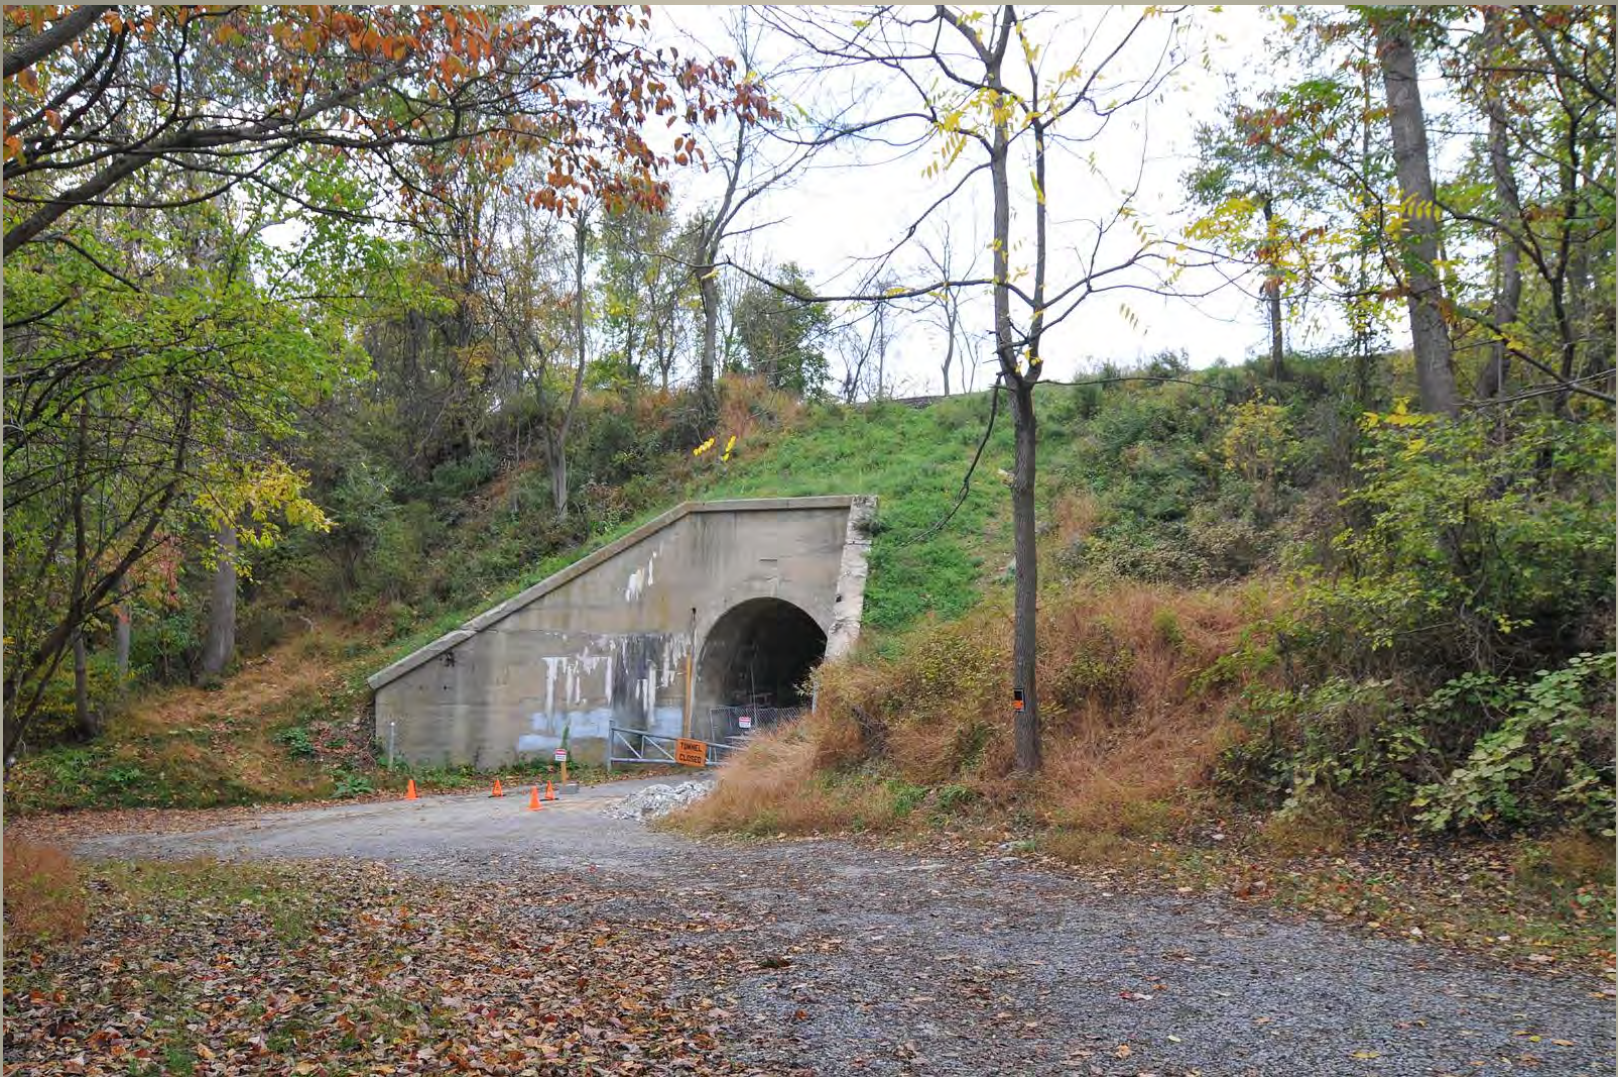
Large trees had grown up over the arch and damaged the original, clay, waterproofing layer. Also, 1911 lengthening of tunnel may not have extended clay layer. This photo taken after removal of trees.

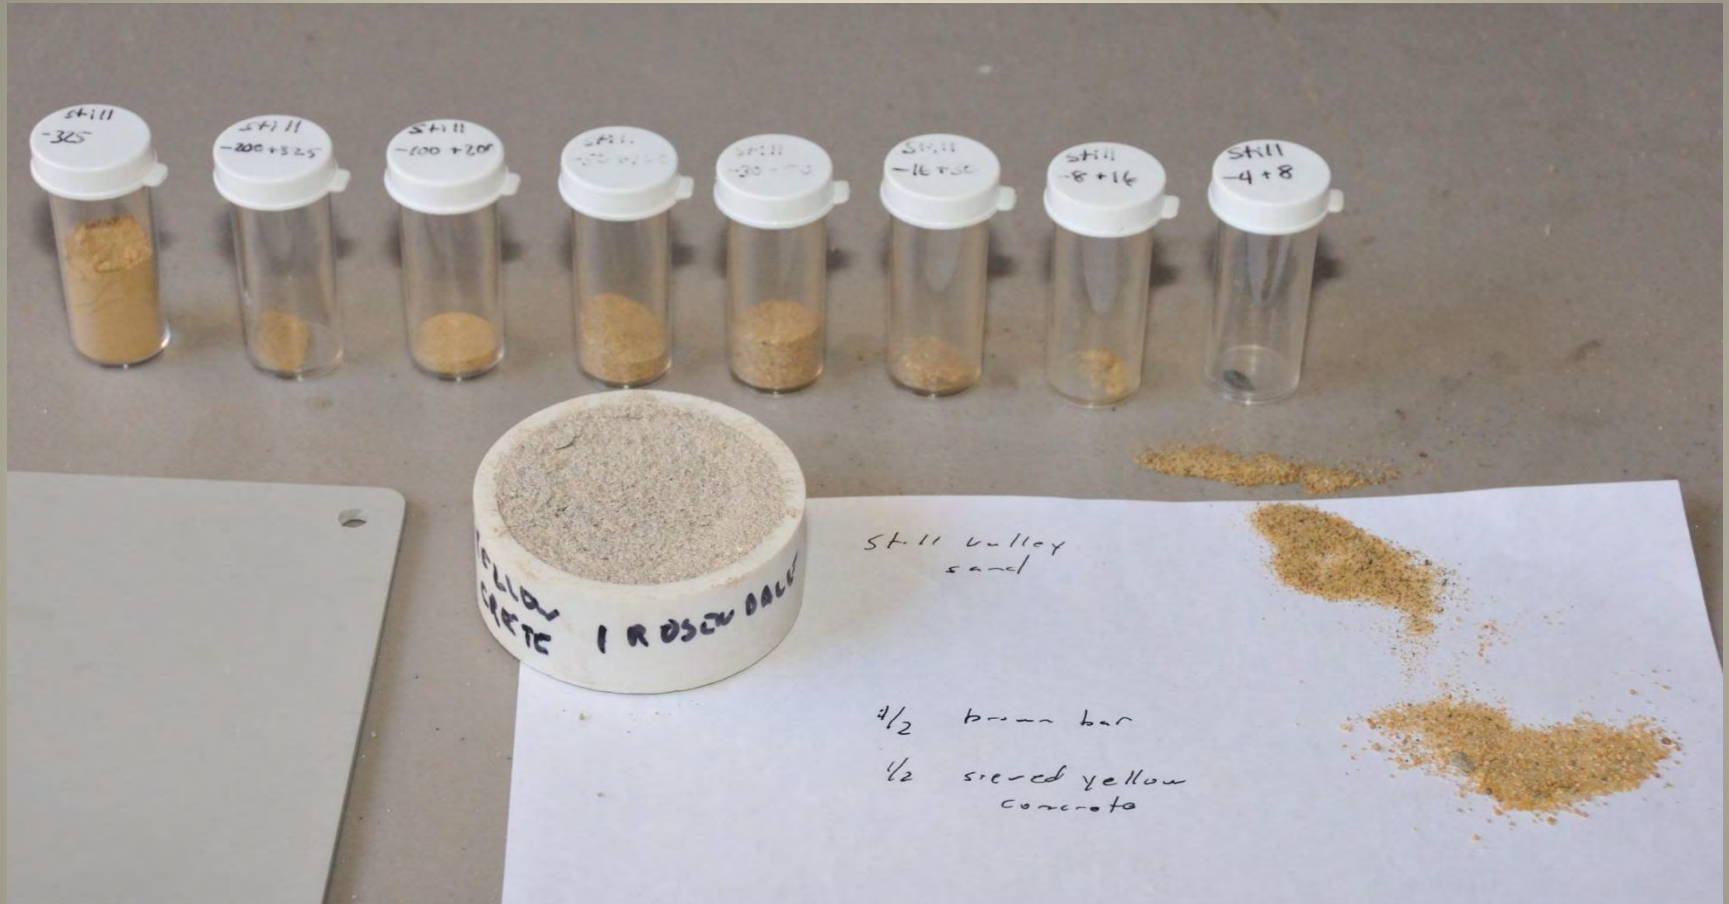
Graded sand from original mortar in bottles, original sand and new blend, and cured mortar sample

- Two sands blended to match original. No clay added.
- Mix of Natural Cement and Hydrated Dolomitic Lime binder used to approximate original properties.
- Mortar Formula - Cement:Lime:Sand 1:1:5
- Binder : Sand ratio: 1 : 2.5

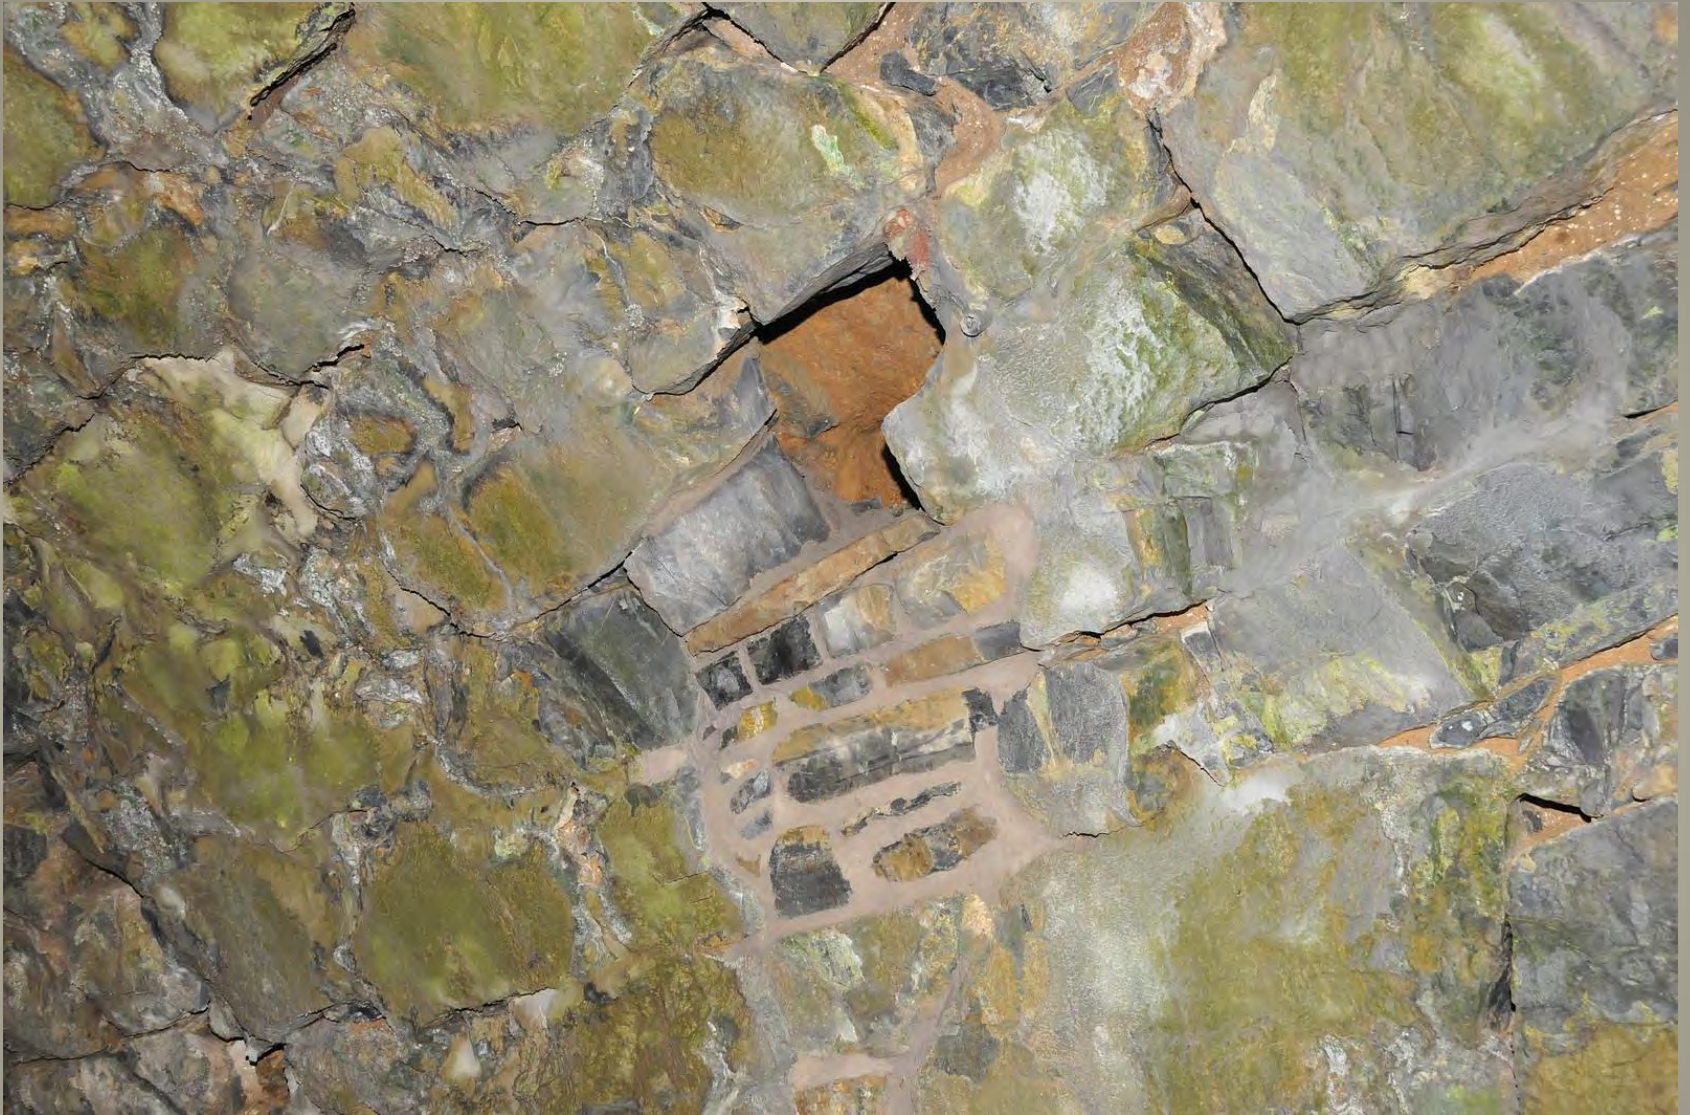
Major part of project as originally planned: replace loose and missing stones.

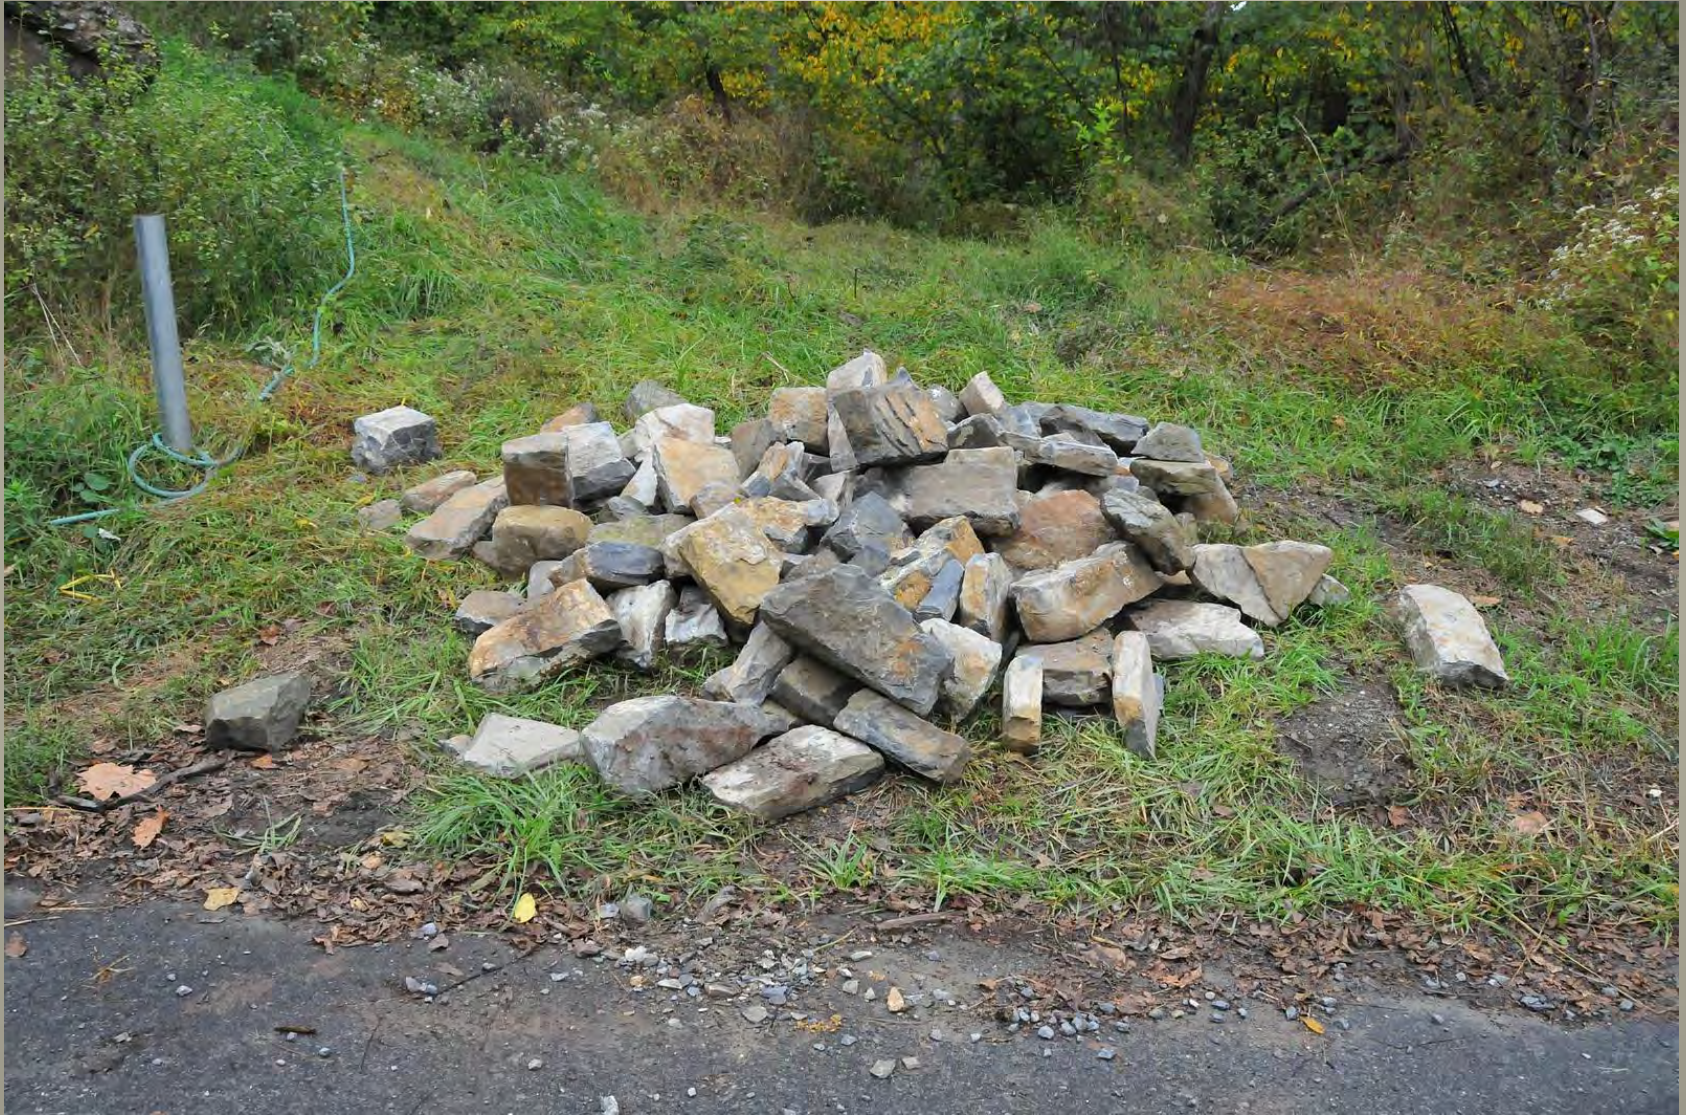
Replacement stone is a higher quality local limestone similar in color and texture

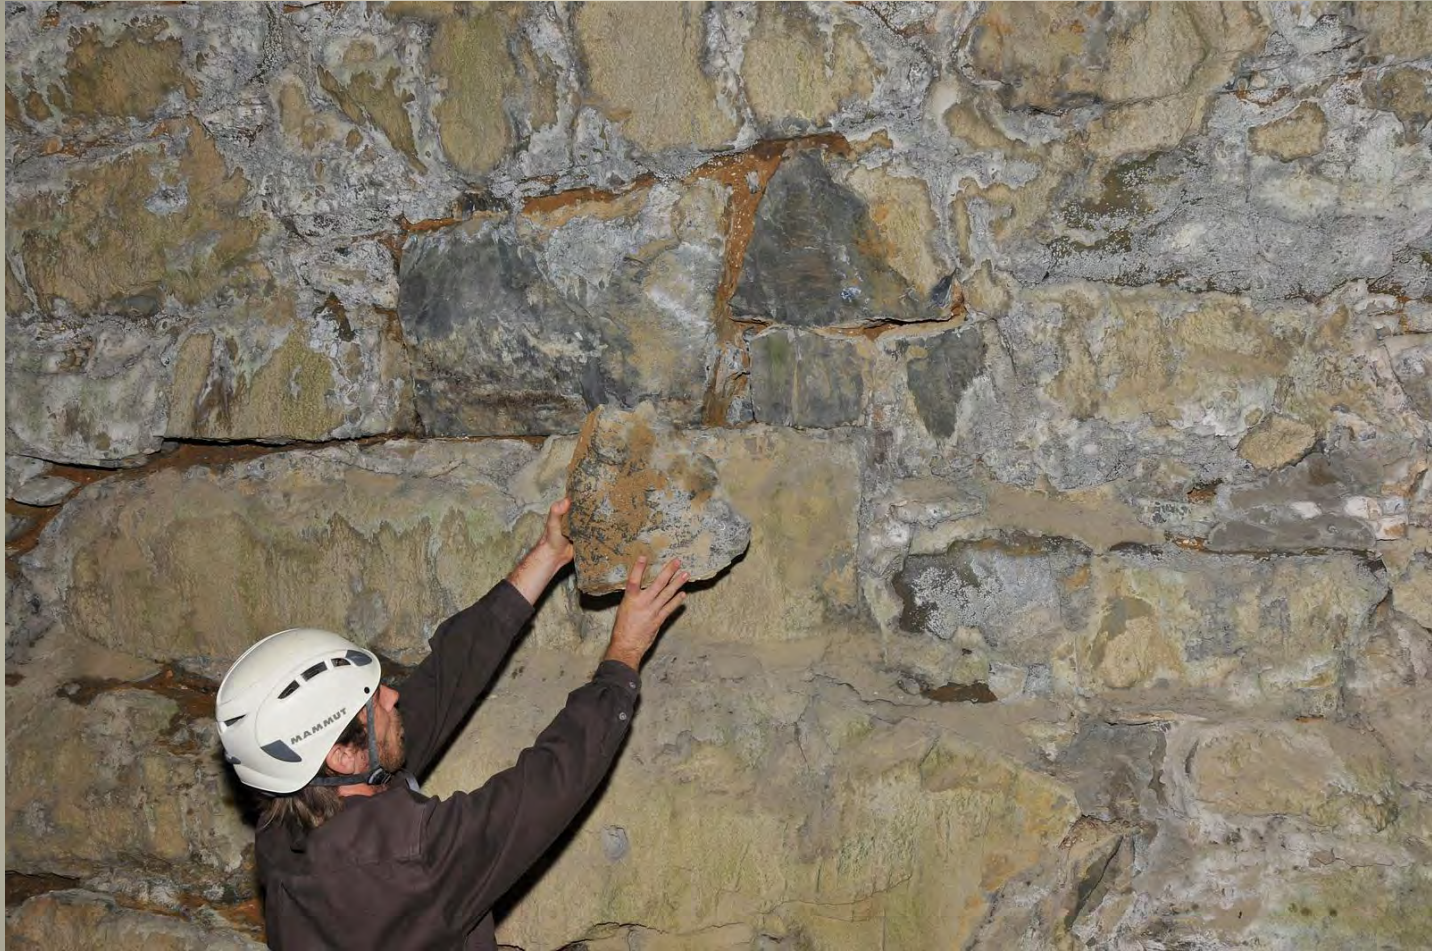
Realization: stones were not falling out; stones were fracturing and spalling.

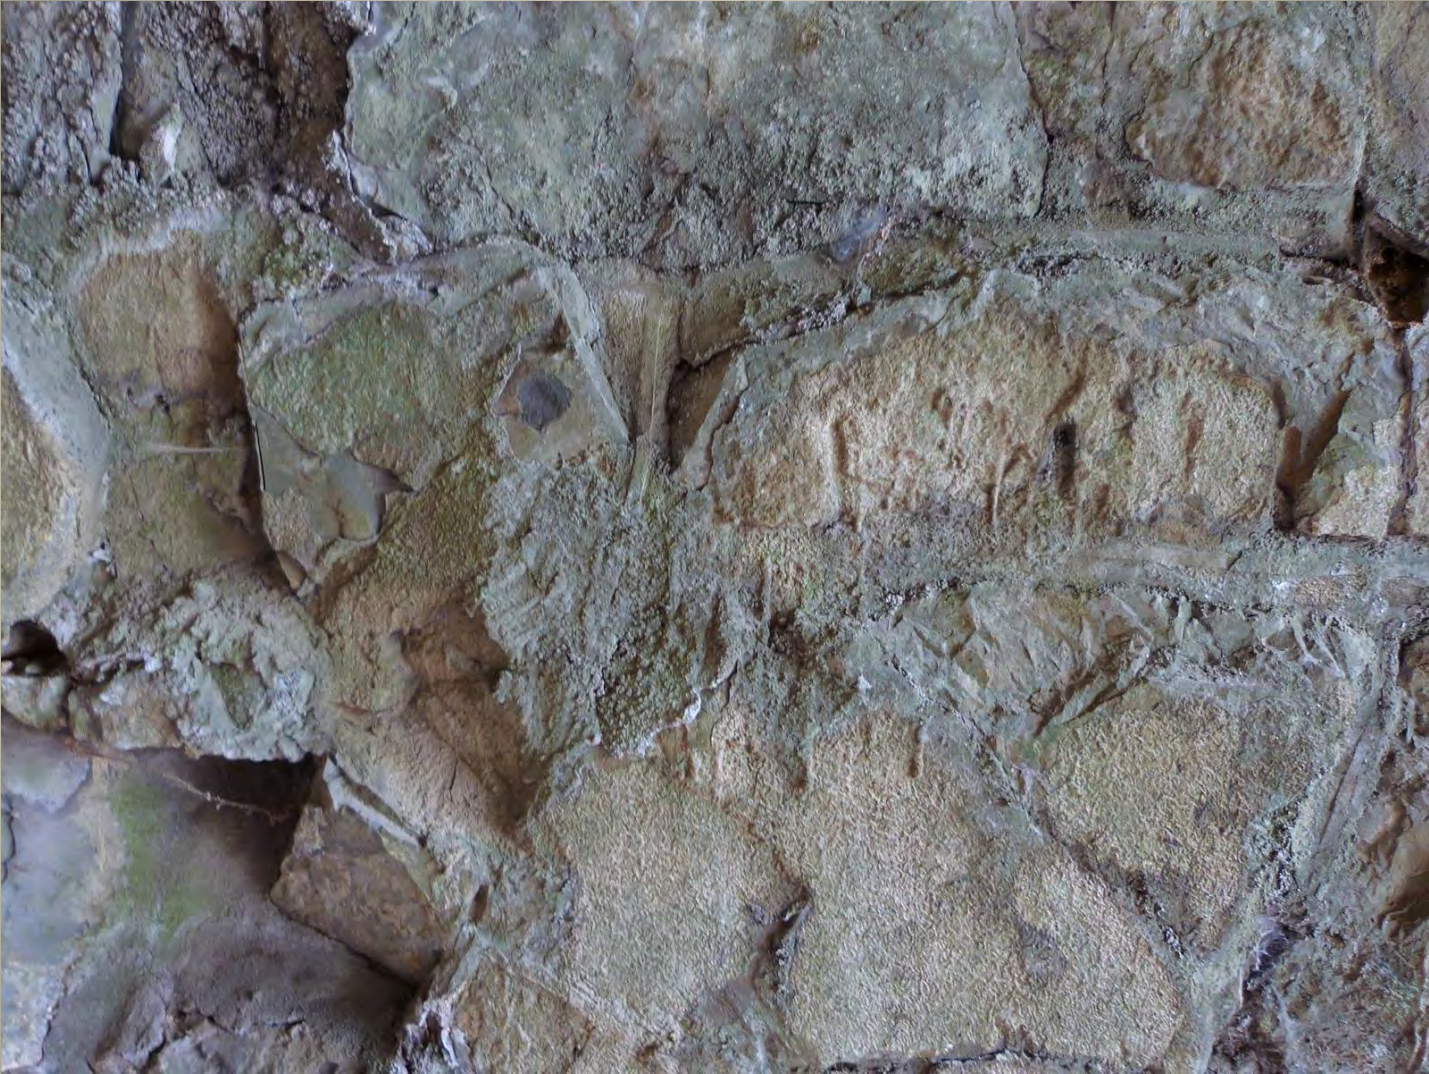
Hard, Portland mortar and Gunite were trapping moisture in stone and joints. Freezing caused poor-quality limestone to spall.

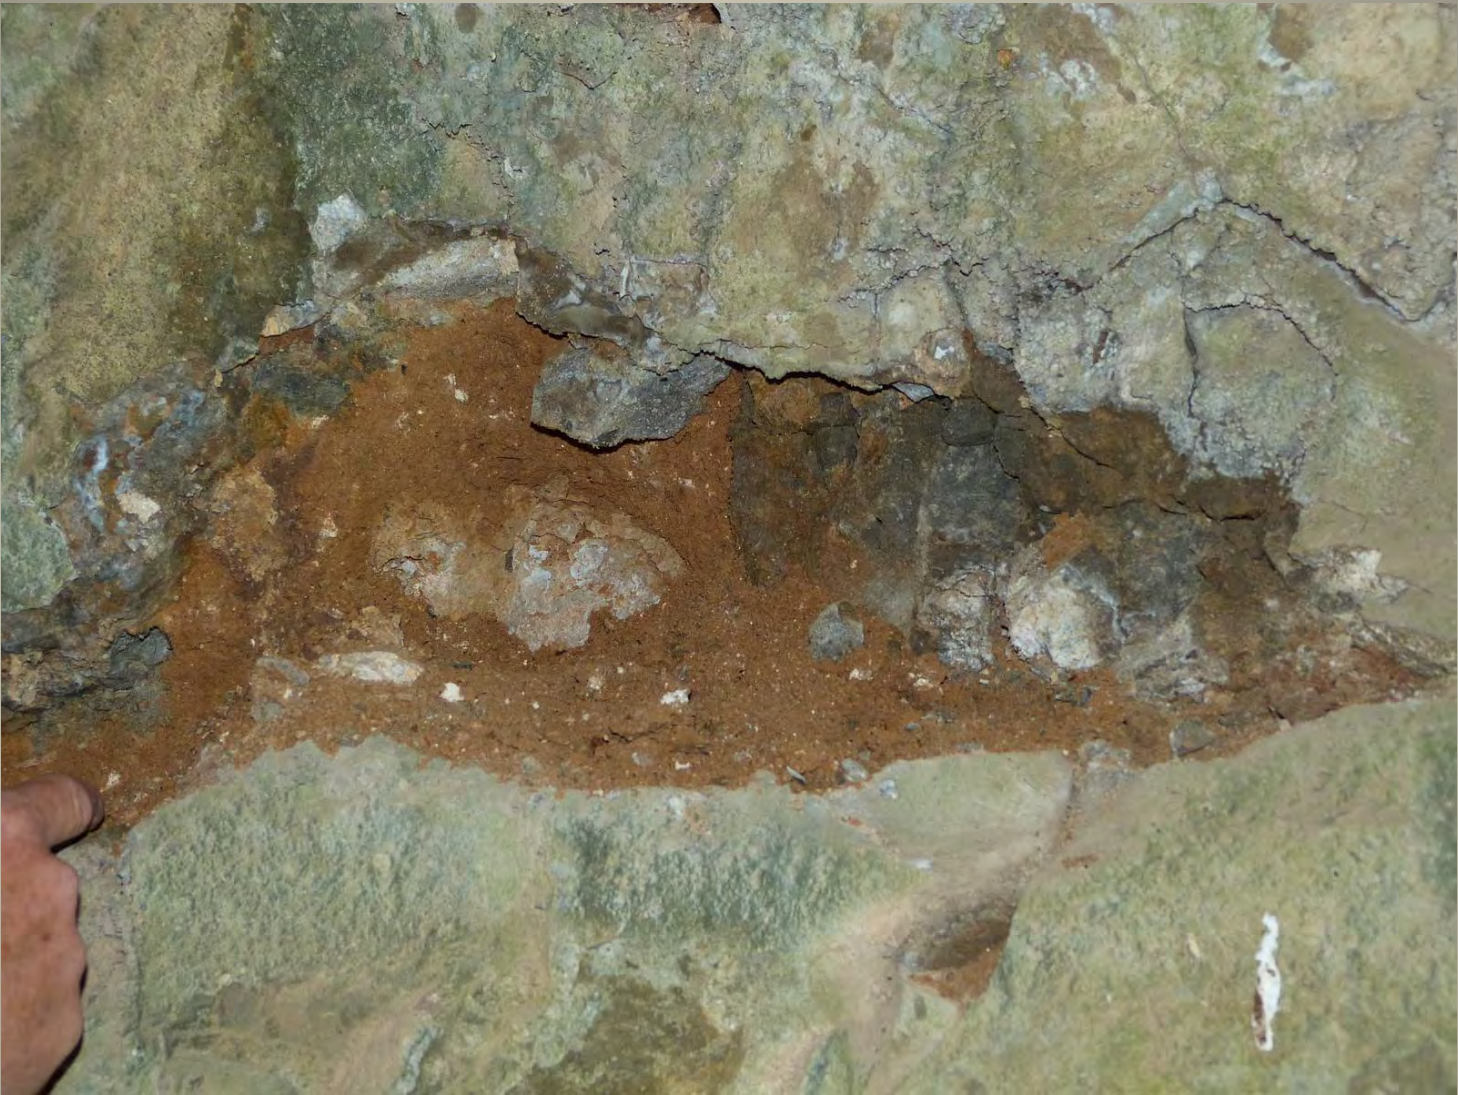
No fitting of stones. Large spaces filled with quick-setting cement mortar. Mortar in excellent condition. No loss or leaching of binder.

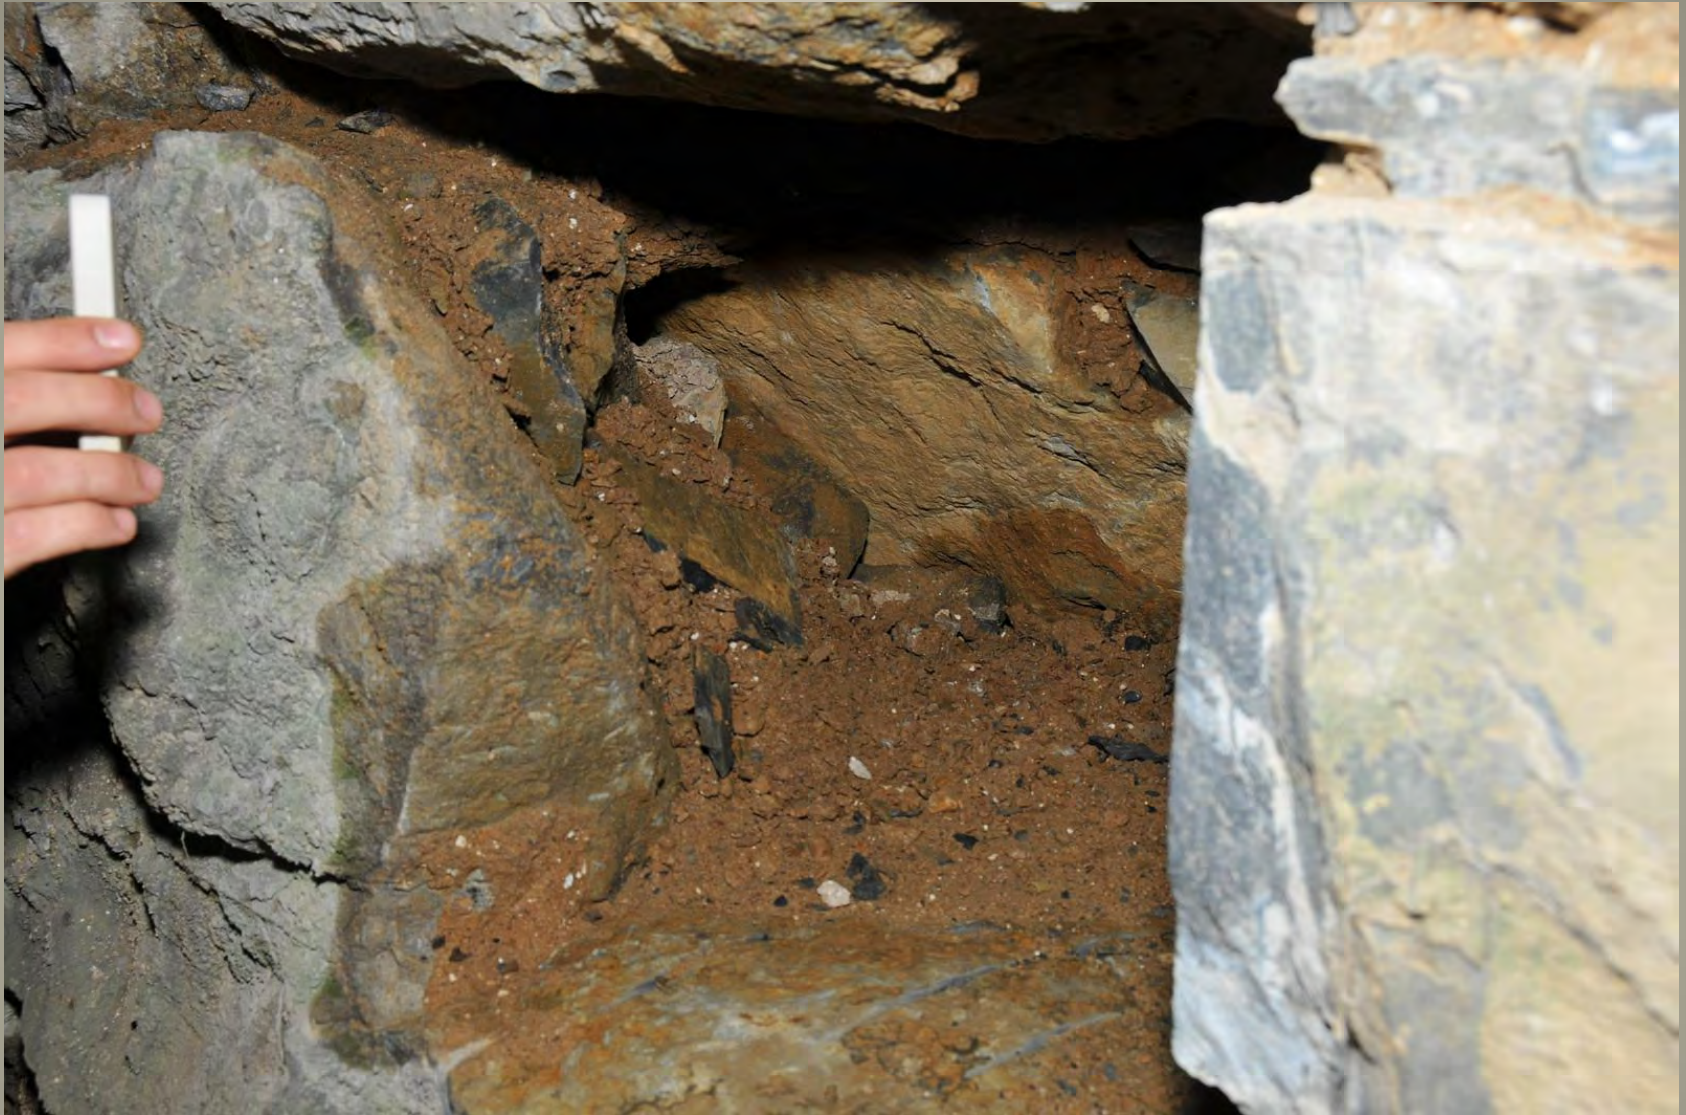
Without quick-setting mortar, it would have taken years for arch to become self-supporting.

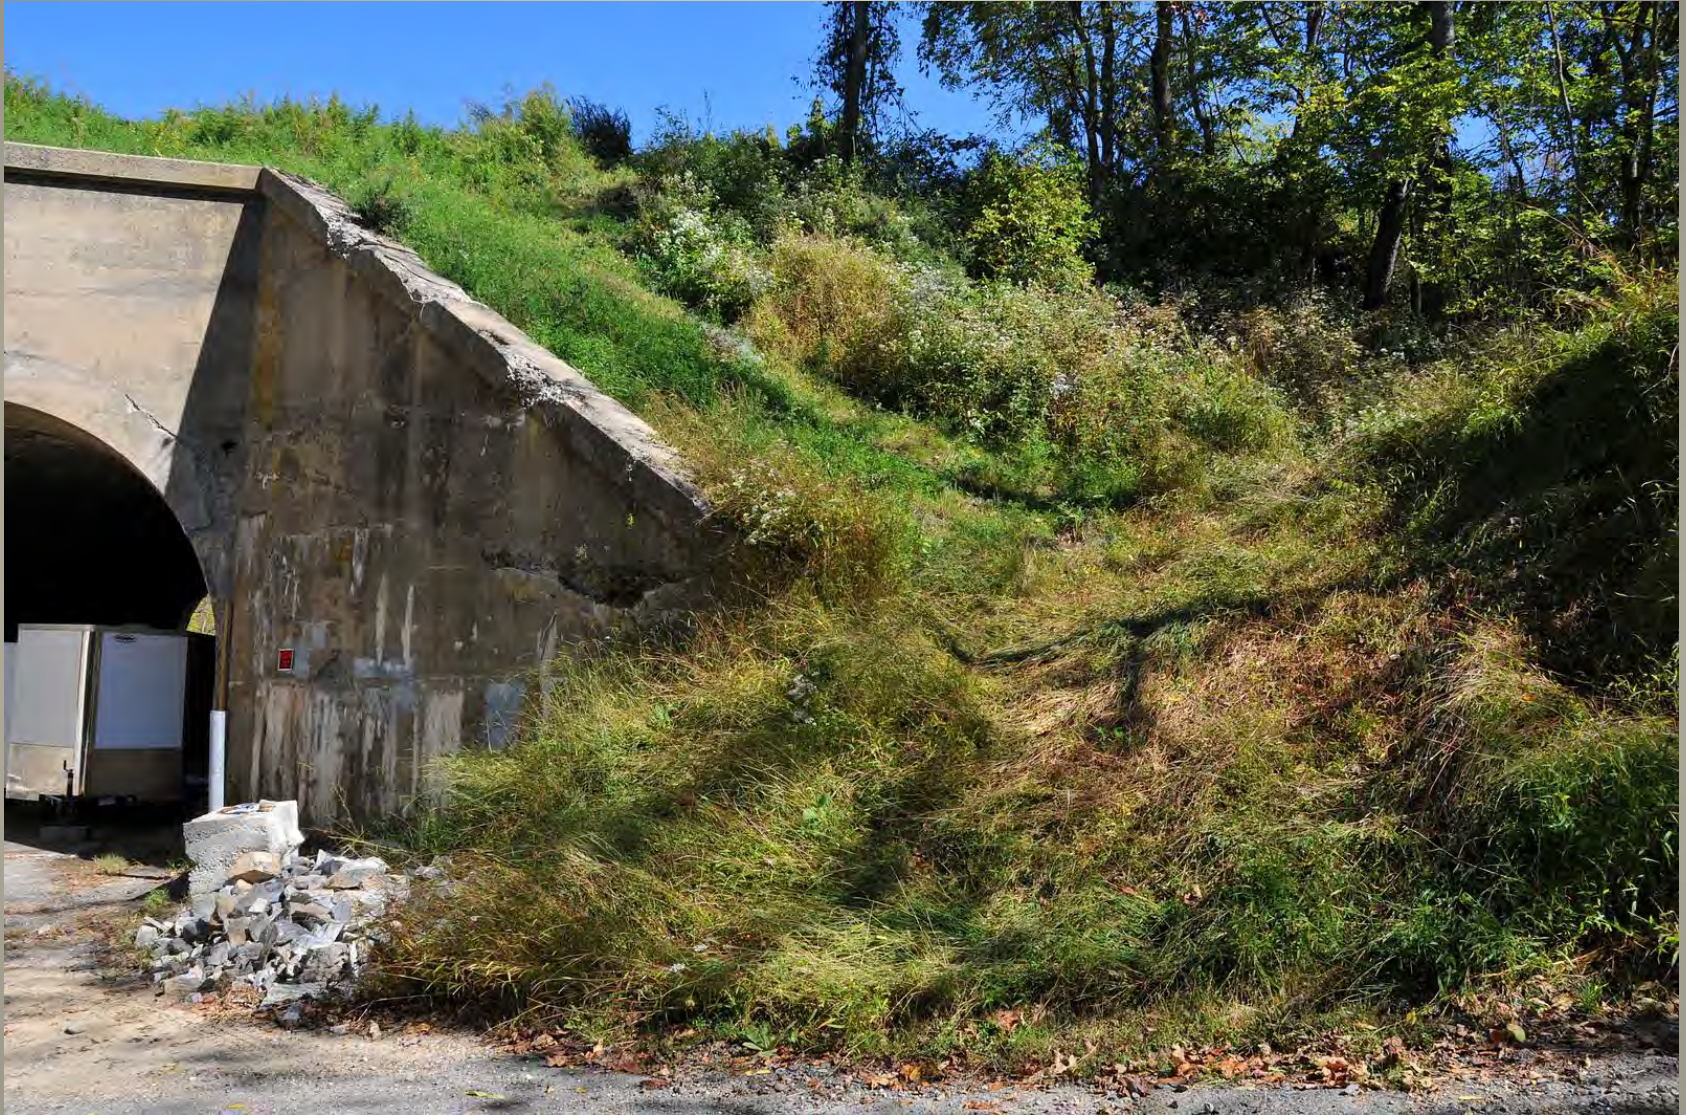
Unexpected problem: the bear slide.

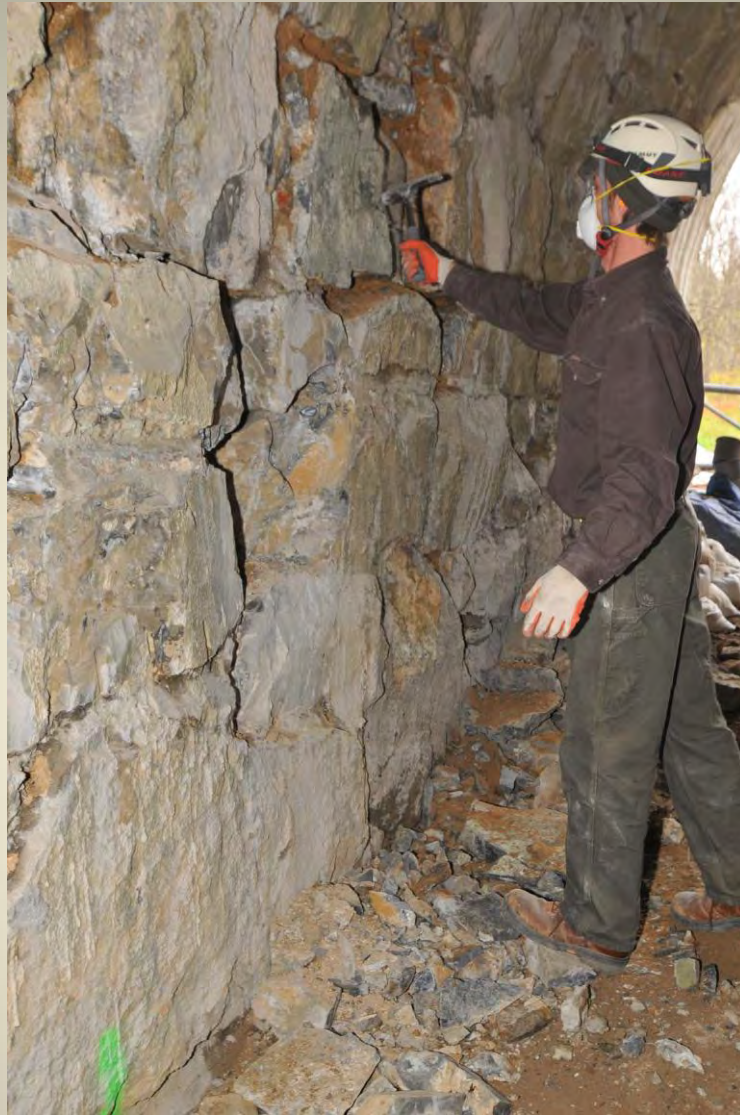
Sounding stones to find delaminated faces.

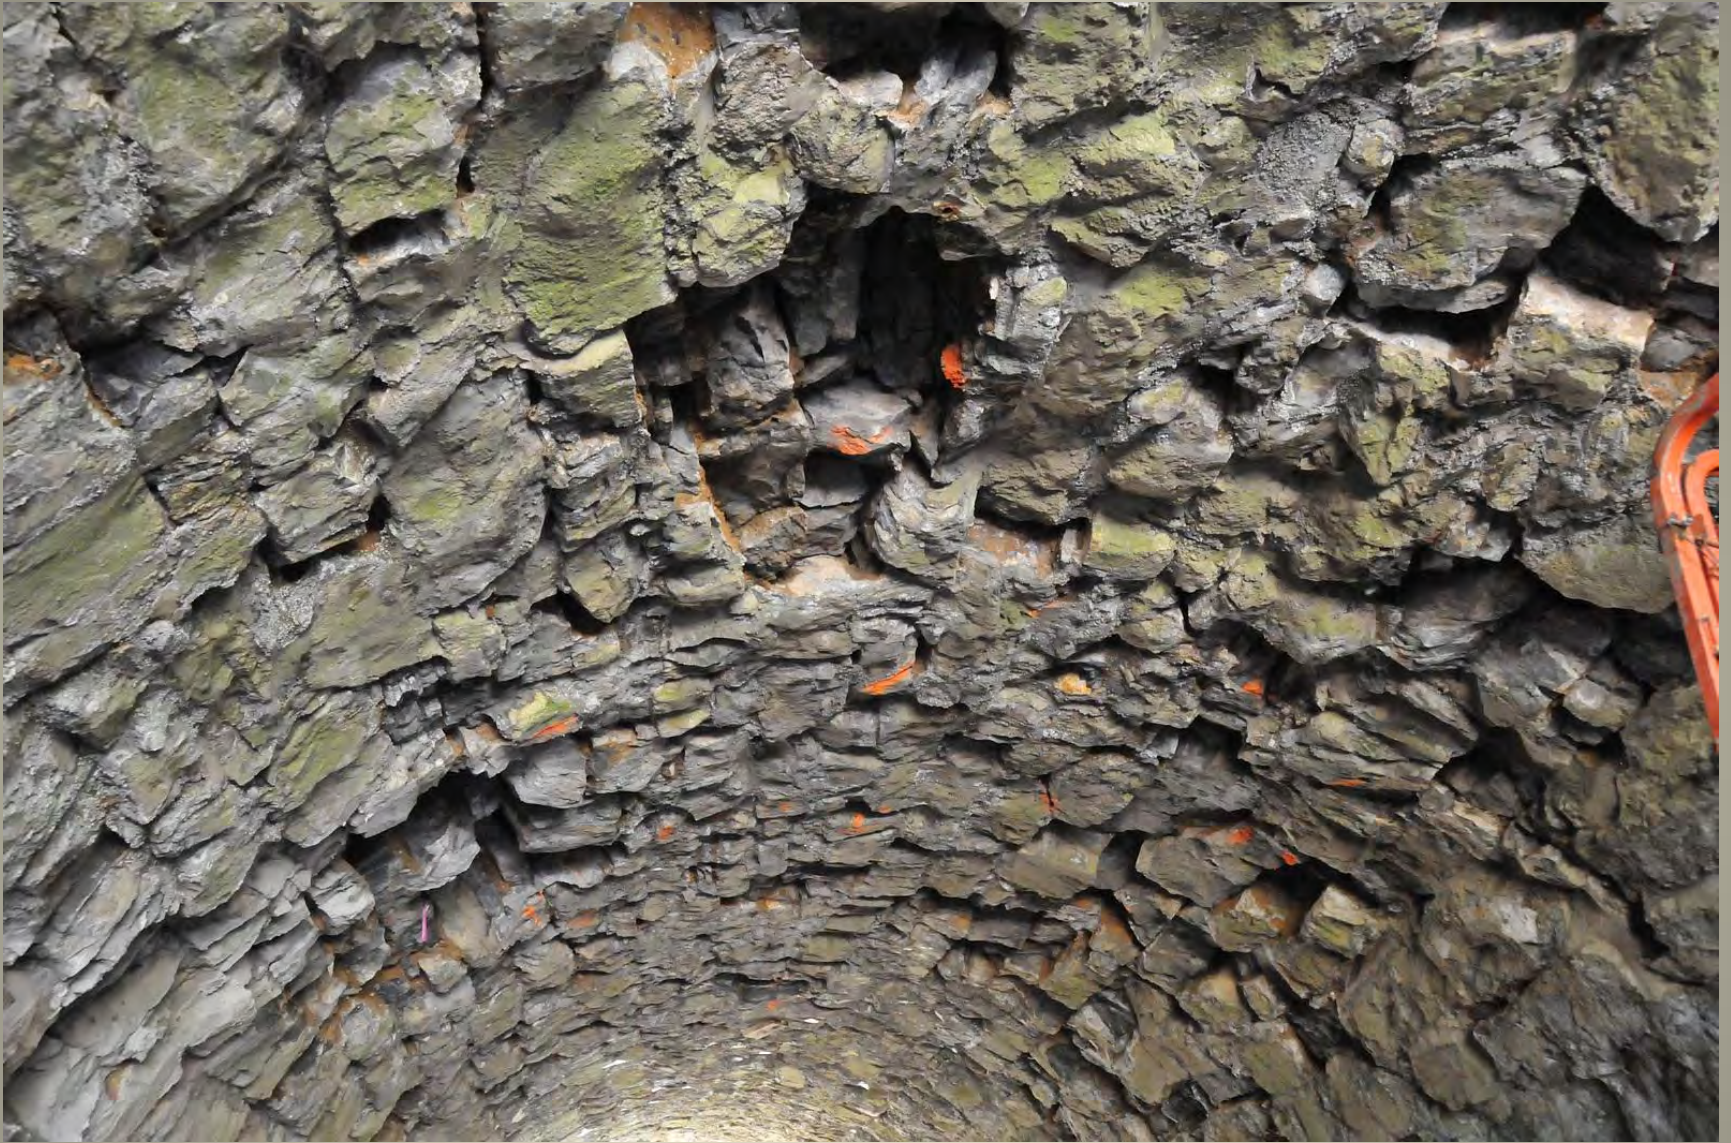
Prepared area ready for insertion of fill stones and mortar.

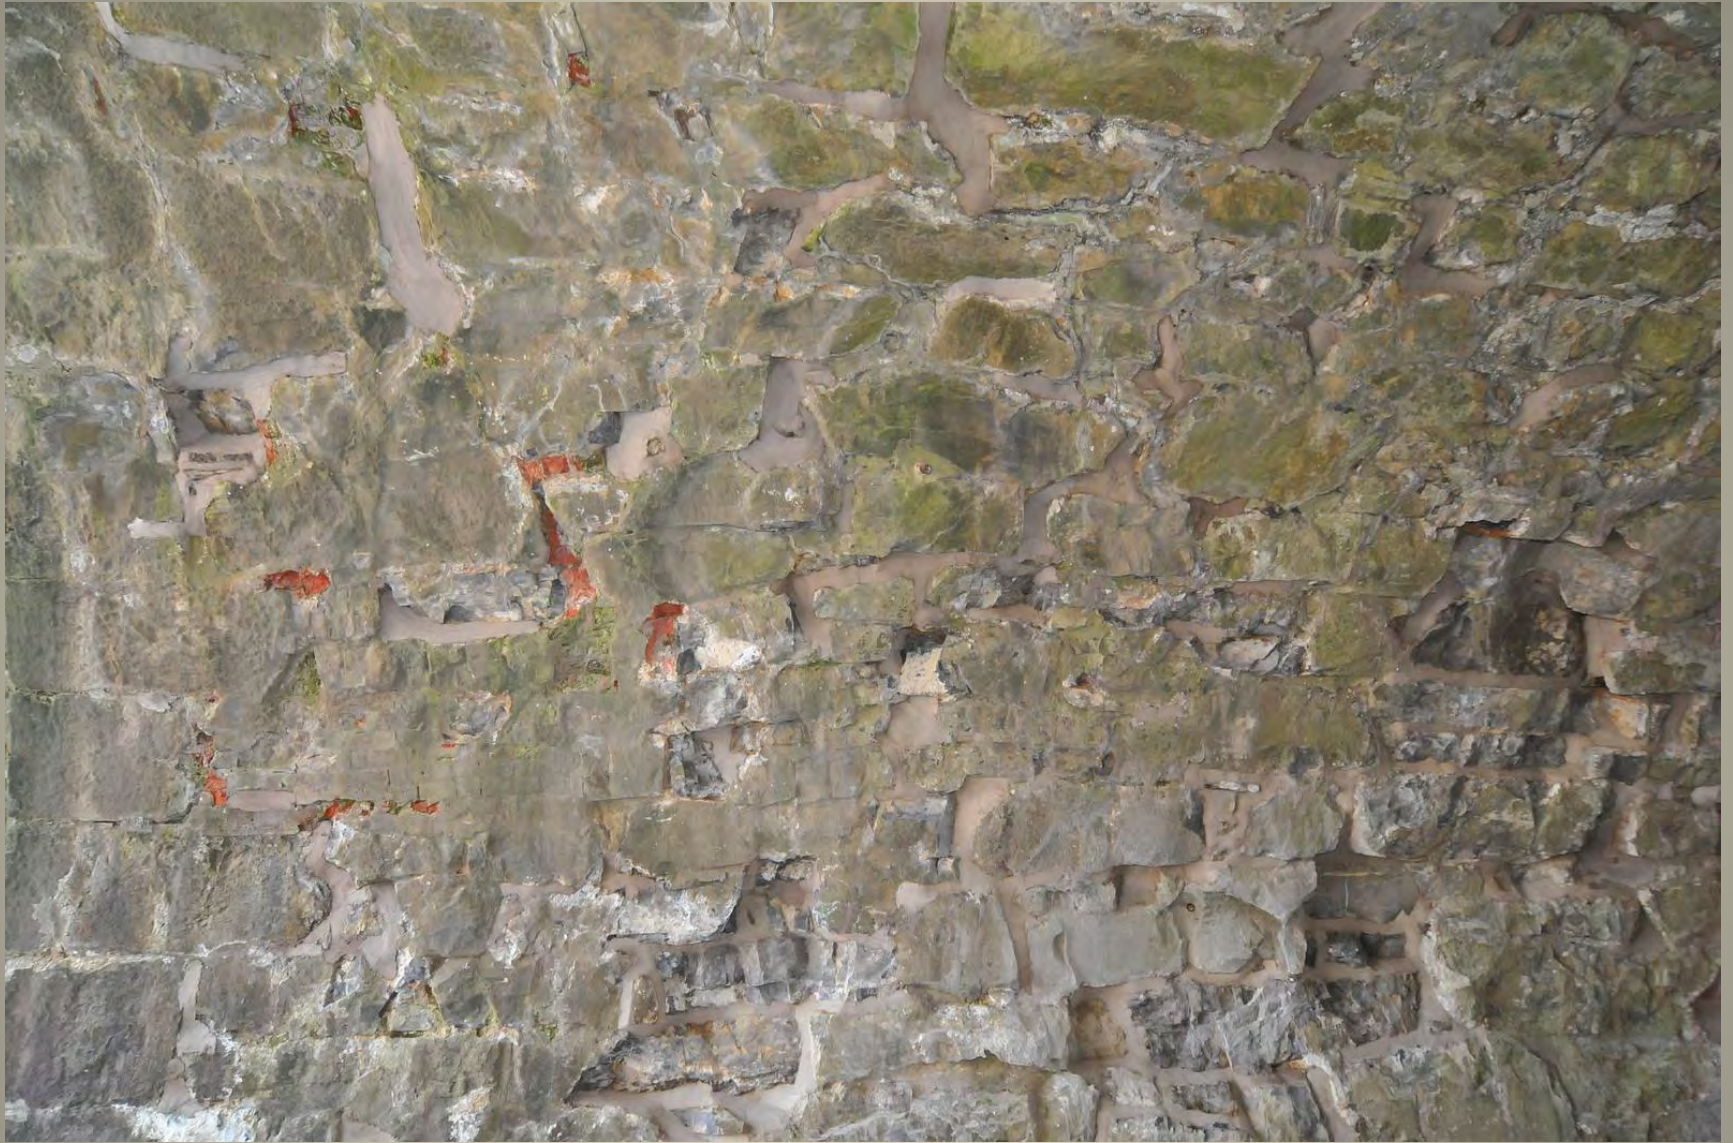
Completed area. Only deep stone spalls refilled with new stone.

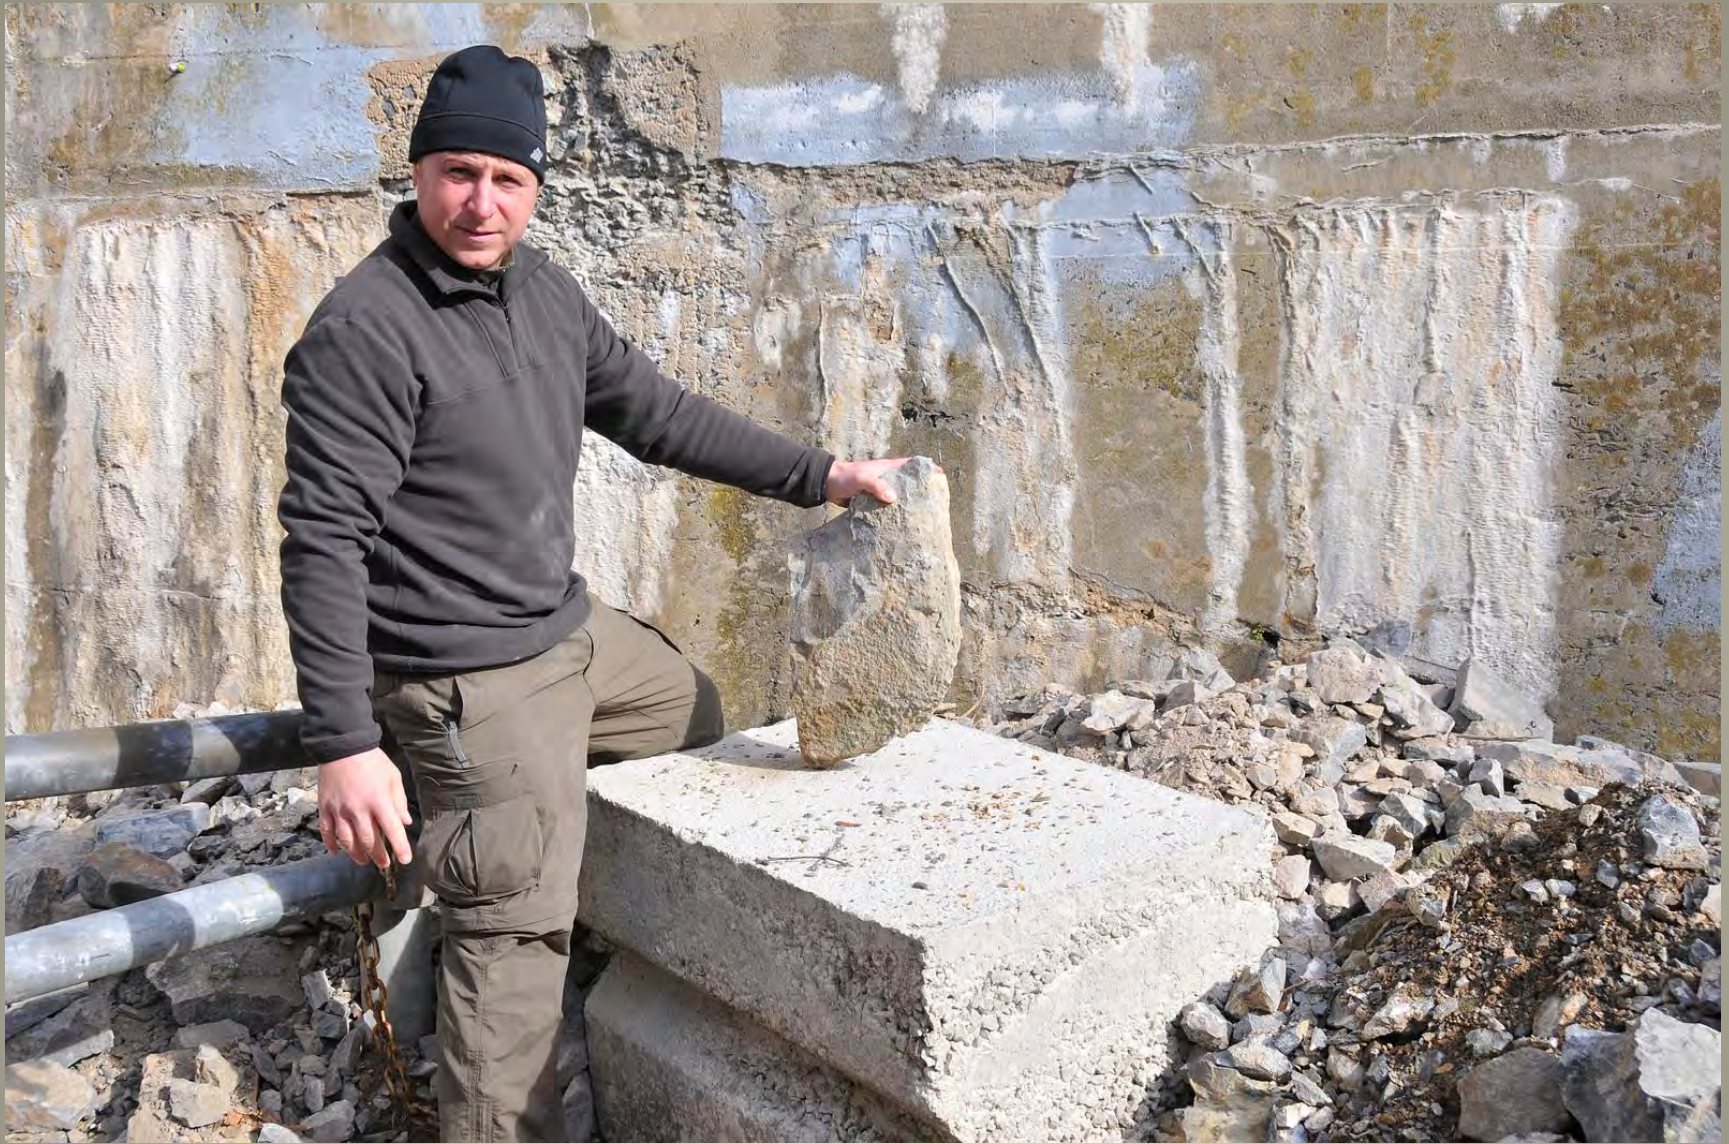
Contractor Steve Ferrari holds typical spalled stone removed from tunnel ceiling
