STILL VALLEY RAILROAD TUNNEL

An Unknown Early Cement in Rural NJ

Still Valley Railroad Tunnel

Presented September 18, 2014 at the Fifth American Historic Cements Conference

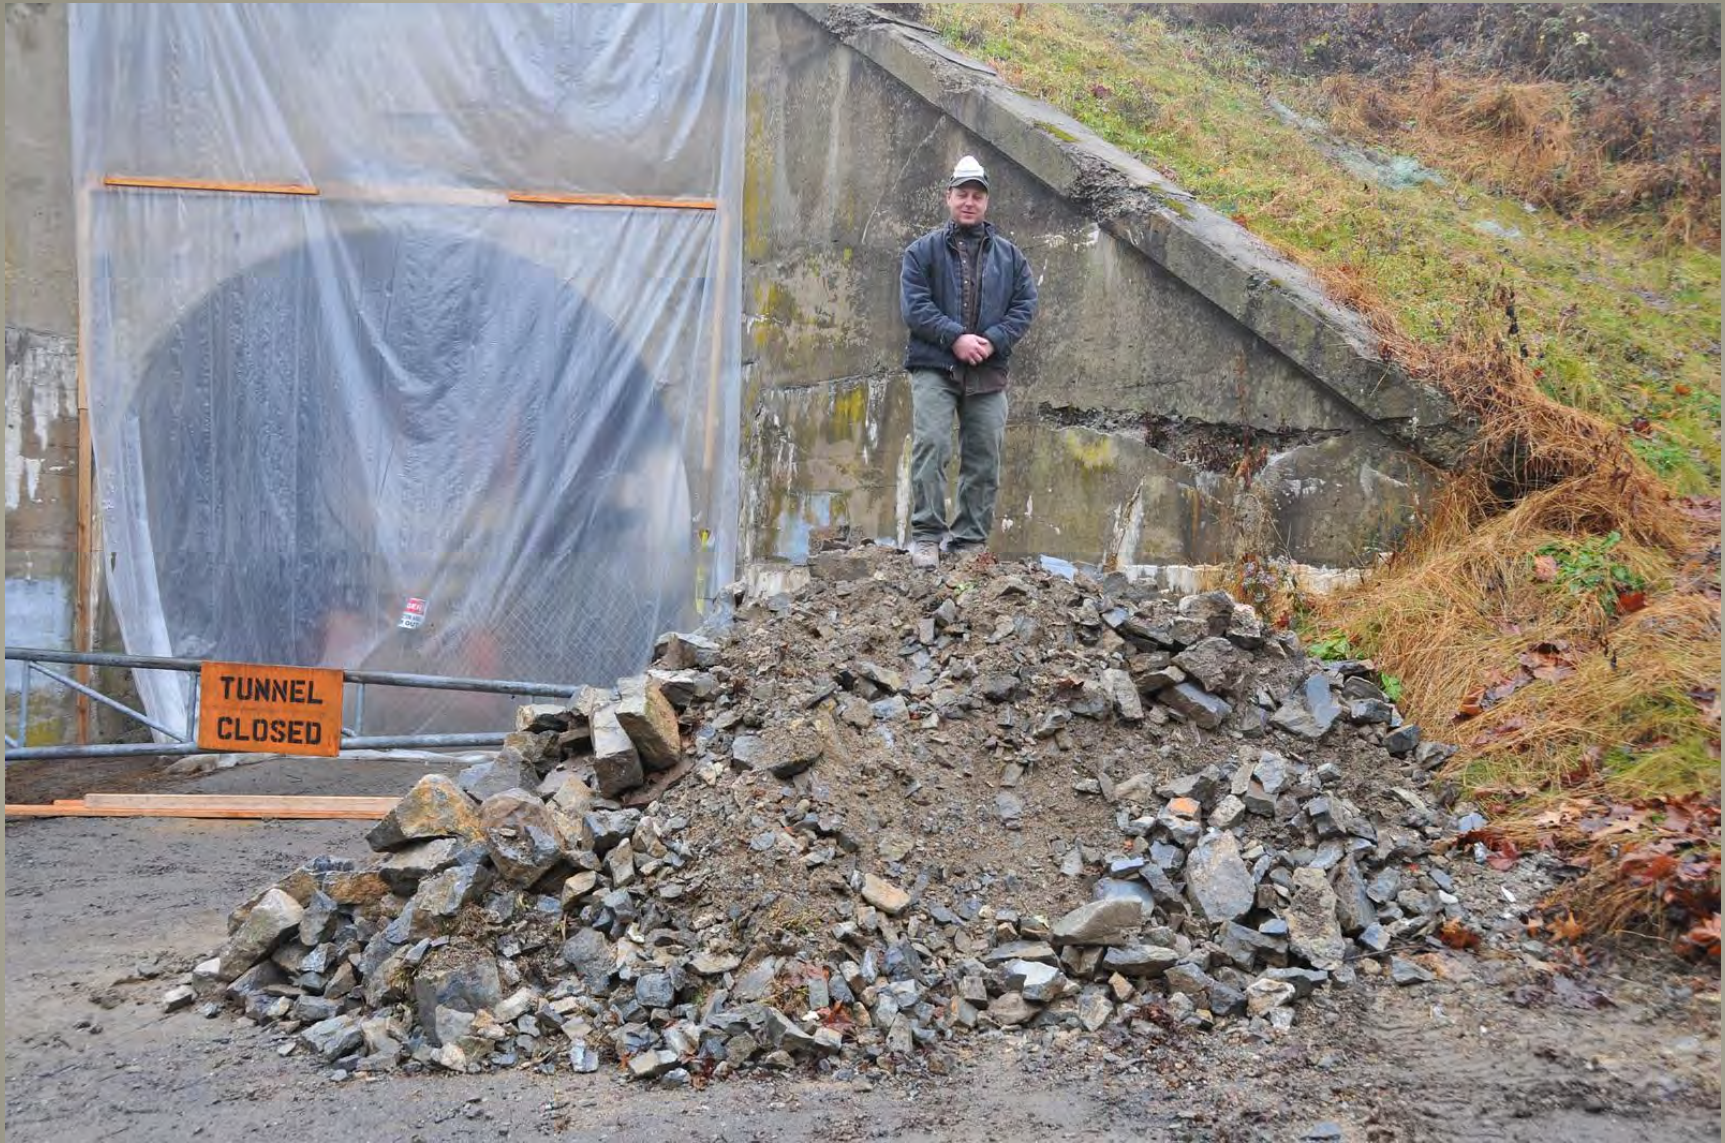
Some of the spalled and fractured stone removed from the surface of the tunnel.

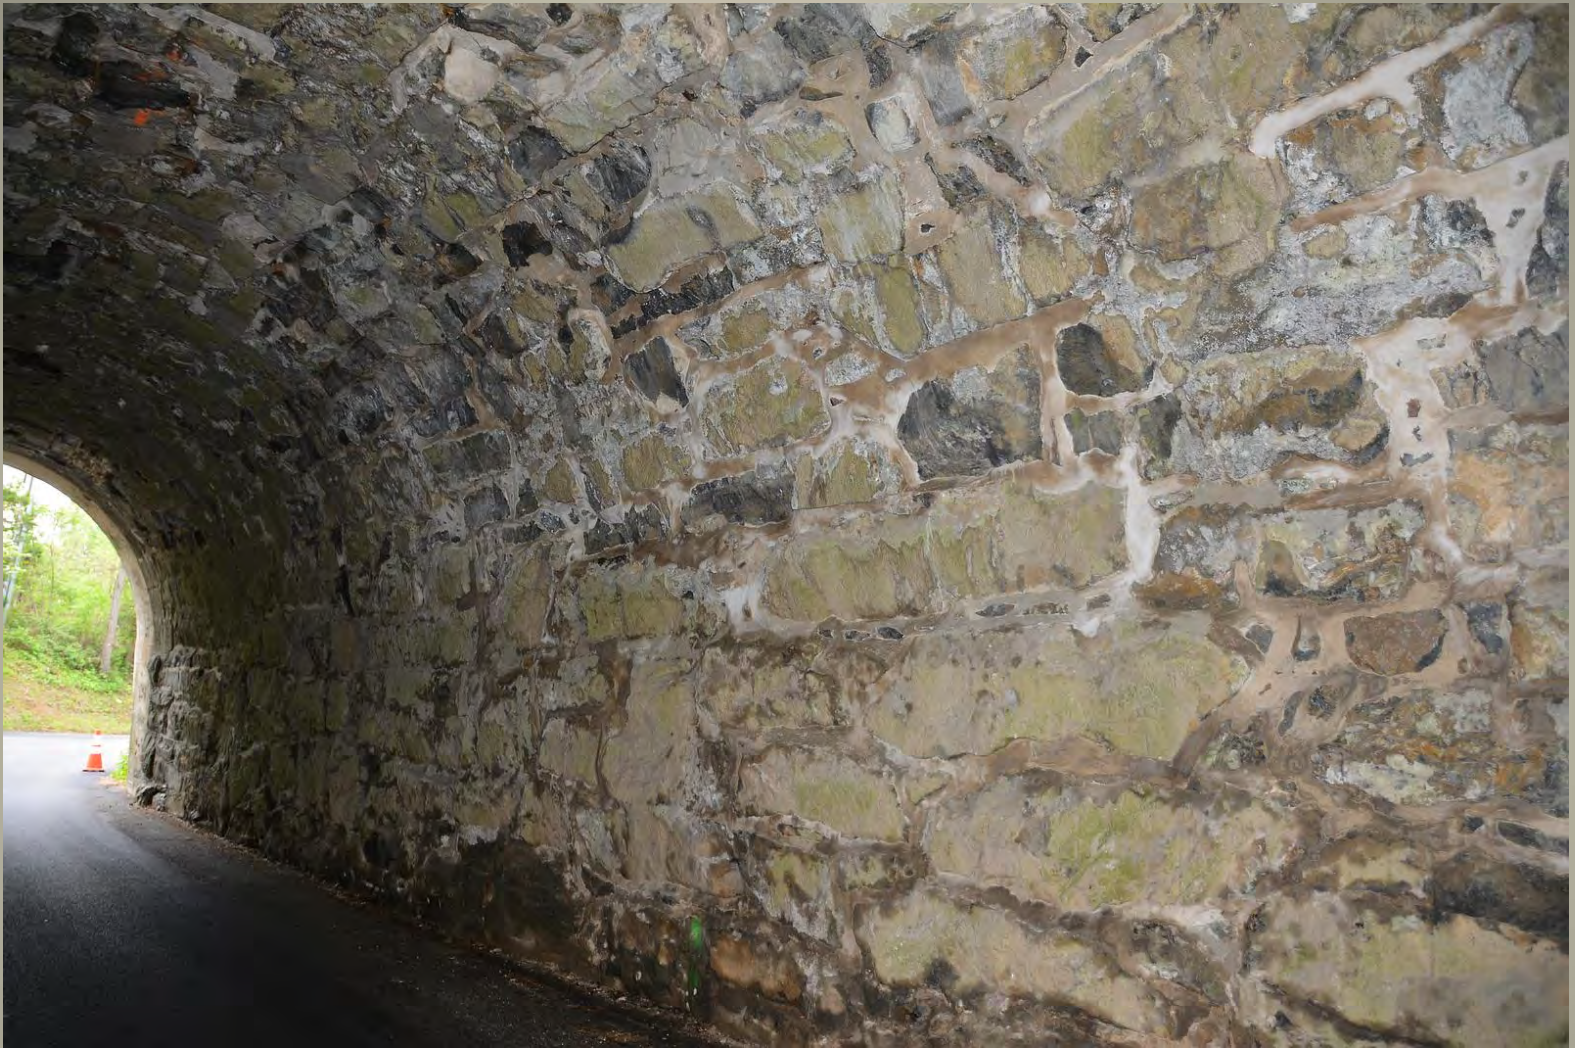
Finished work. Lighter mortar indicates areas that are drying out. No funds available to address appearance issues. Would be possible in the future to remove Gunite, unmatching mortar, and dirt.

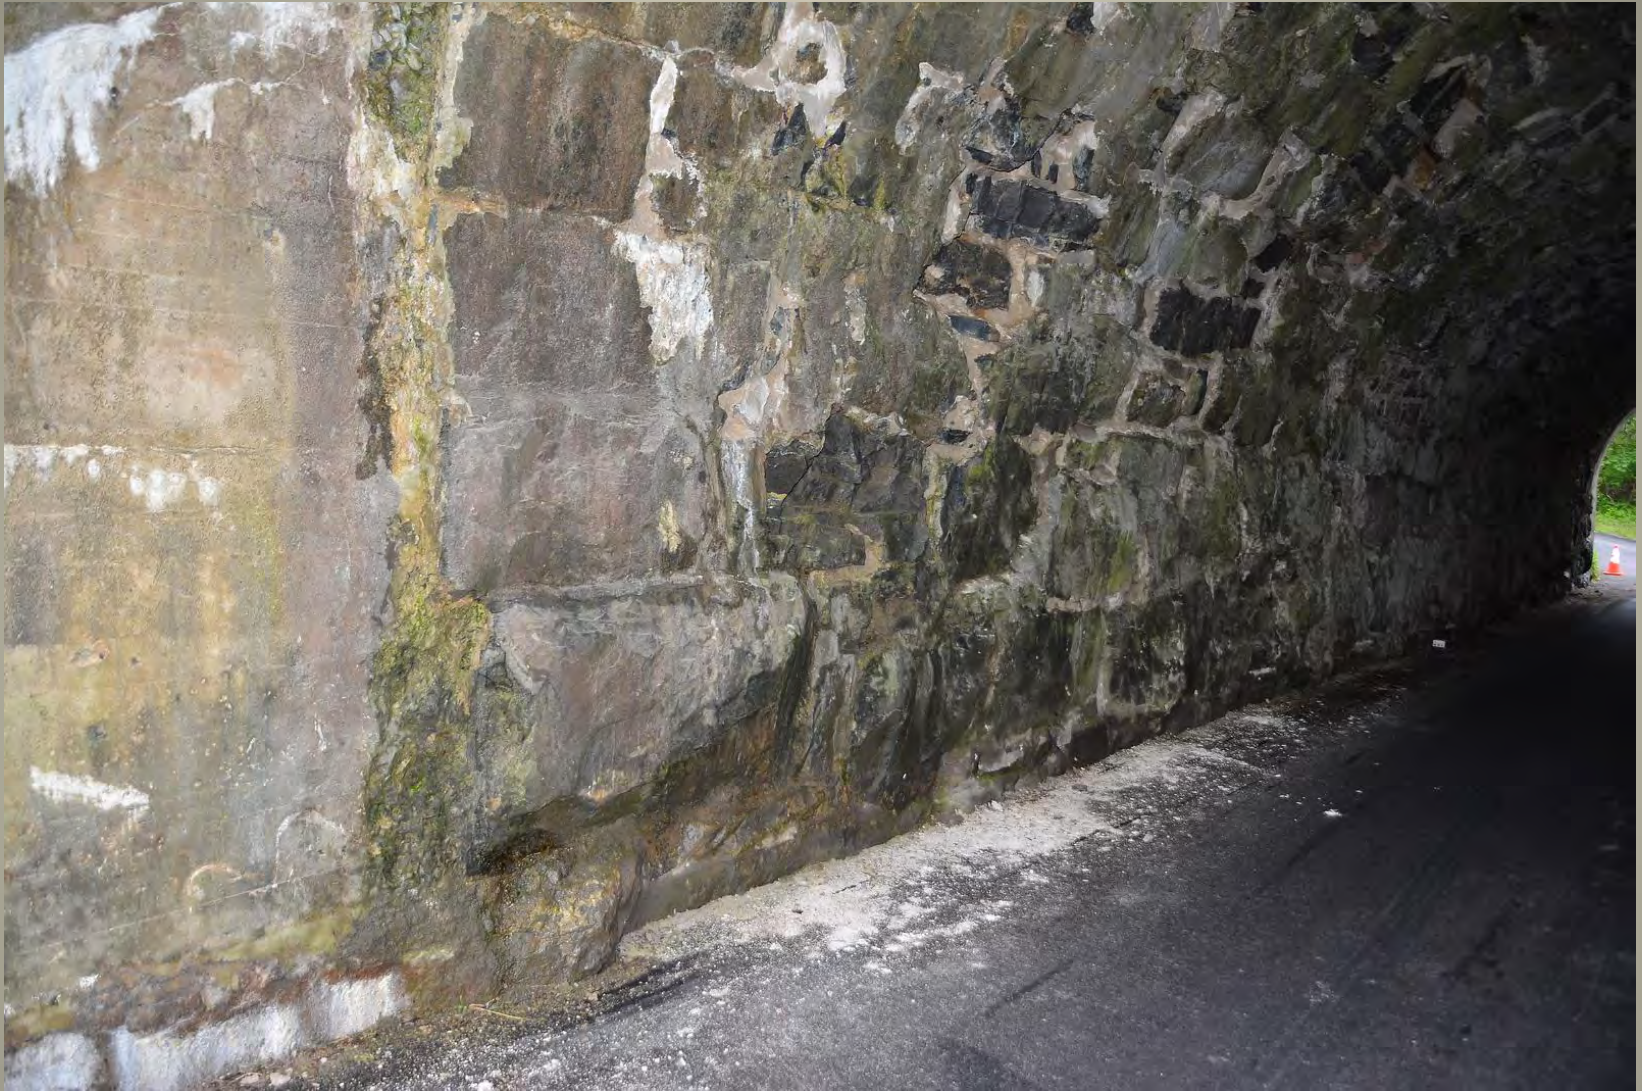
Continuing moisture intrusion and damage at north end of tunnel. Protective membrane over top of tunnel was not connected to concrete end walls. Water gets in between.

- Concrete end walls should be repaired.
- Leaks at the end of the tunnel must be corrected.
