# Characterization of Cements from the Civil War to the Spanish American War Era in Coastal South Carolina

Denis Brosnan, Clemson University

Rick Dorrance, Ft. Sumter National Monument

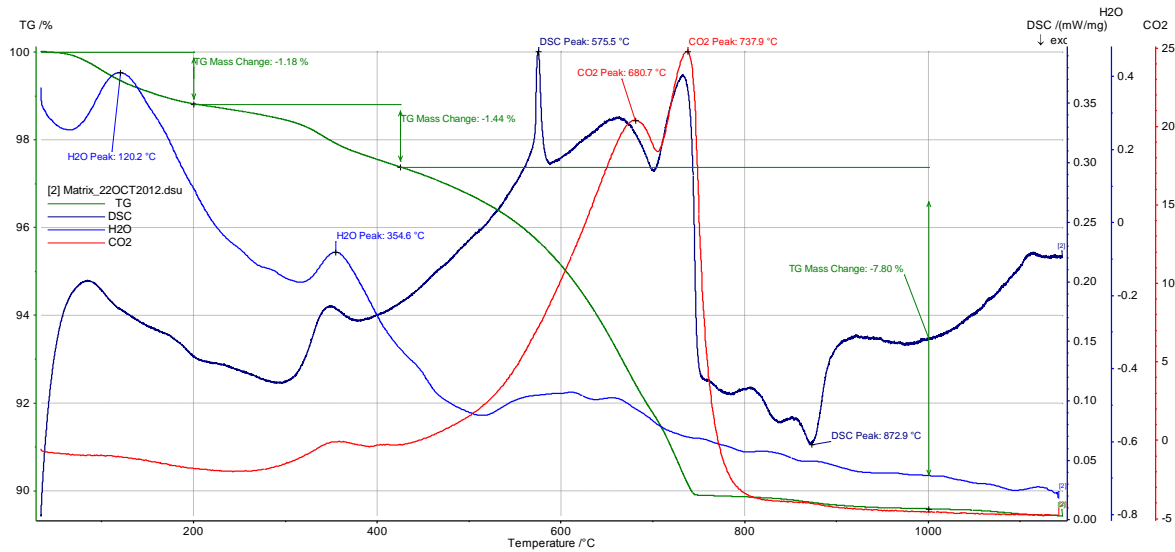
## Fort Fremont (1899) ; Twin Dolomite Peaks of an Intensity in Natural Stone

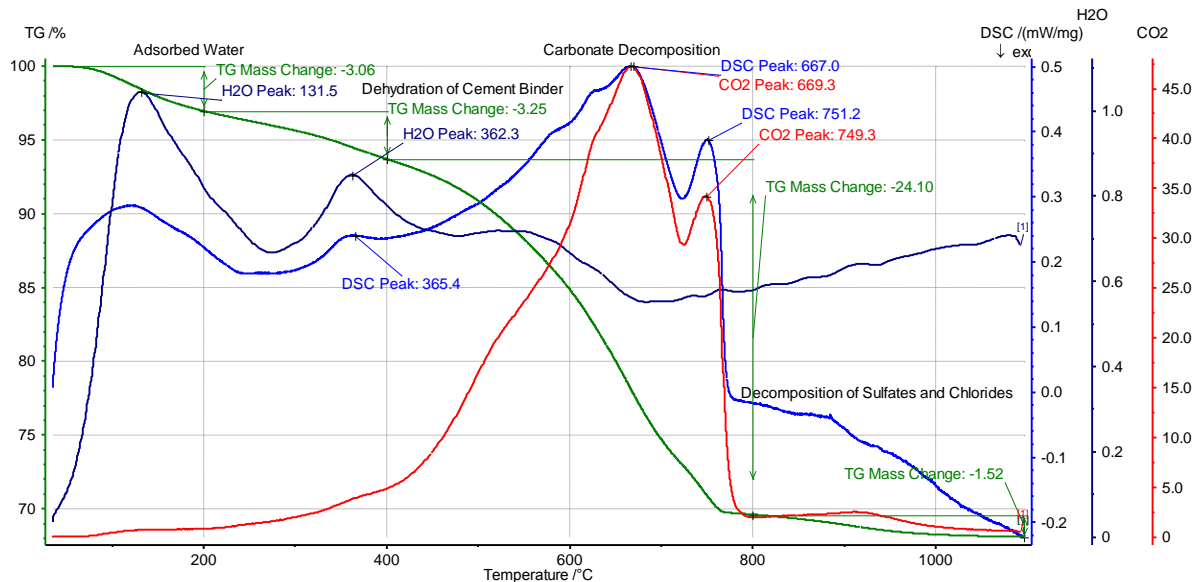
## Fort Sumter (ca. 1845), Reverse intensity of carbonate peaks.

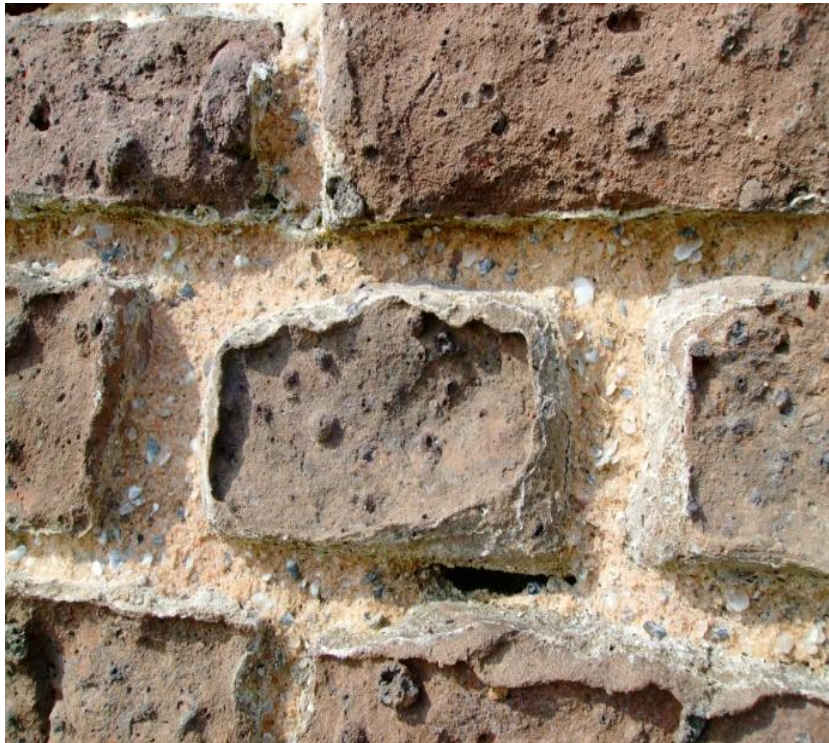
Right Flank Wall

Original Rosendale-Lime-Sand Mortar after  
Wearing Away of Portland Pointing  
Mortar Installed In the 1960's

- Bulk density: 1.23-1.81 g/cm<sup>3</sup>
- Porosity: 22.7-44.1%
- Rosendale cement
- Composition:

Cement: Lime : Sand

Range 1: $\frac{1}{2}$ :2 to 1:4:9

Or, 1 (cement + lime) : 2 (sand)
- Mineral alteration by seawater as:  
Magnesium uptake  
Leaching of lime (CaO)

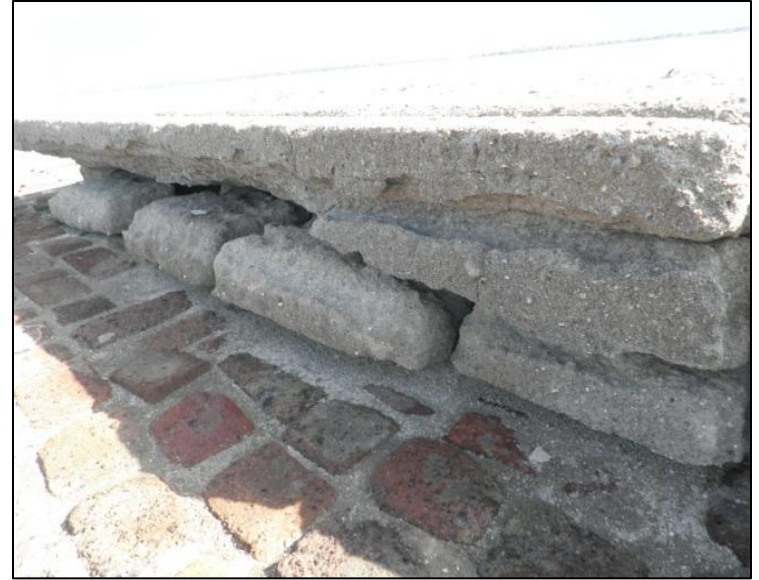
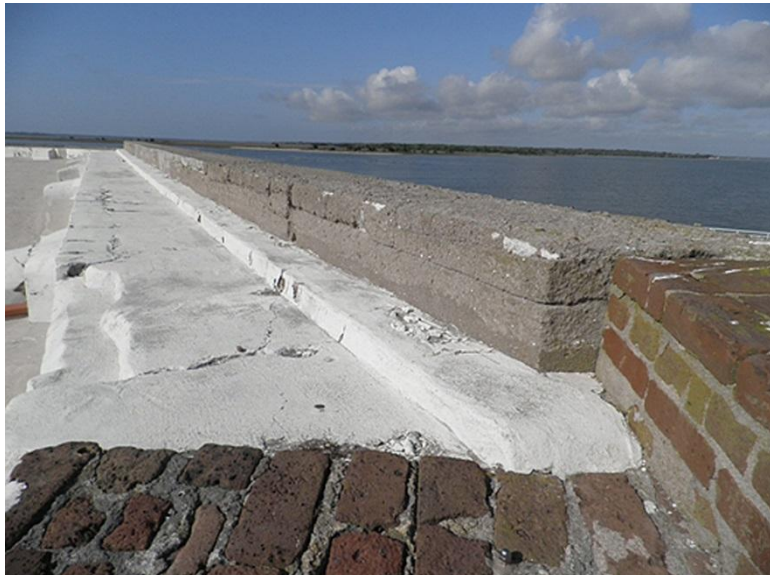
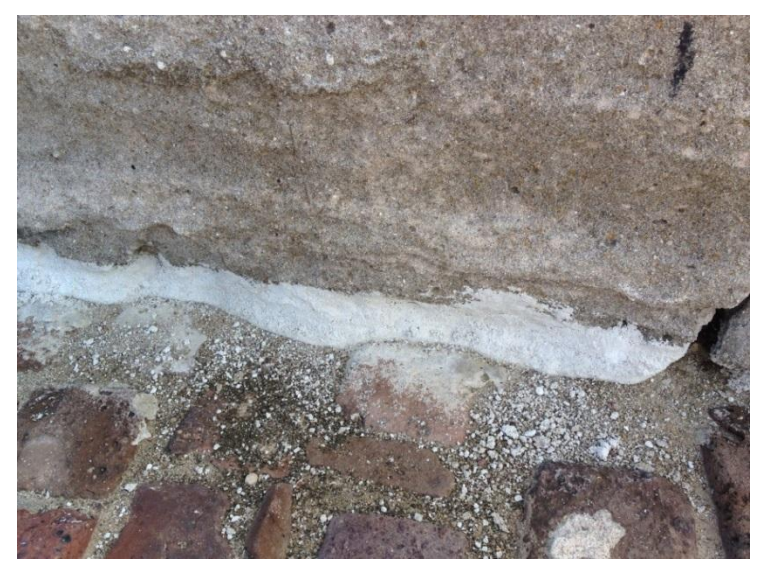
# 1873 Concrete Coping Blocks

The coping block’s nominal composition at Ft. Sumter was determined as:

*½ part of Portland cement to 1 parts of lime to 5 parts of sand (by volume)*

The coating composition was determined as:

*1 part of lime to 2 parts of sand (by volume)*

Property	Concrete	Coating
Bulk density, g/cm <sup>3</sup> (pcf)	1.94 (121)	1.72 (107)
Apparent Porosity, %	24.5	30.9

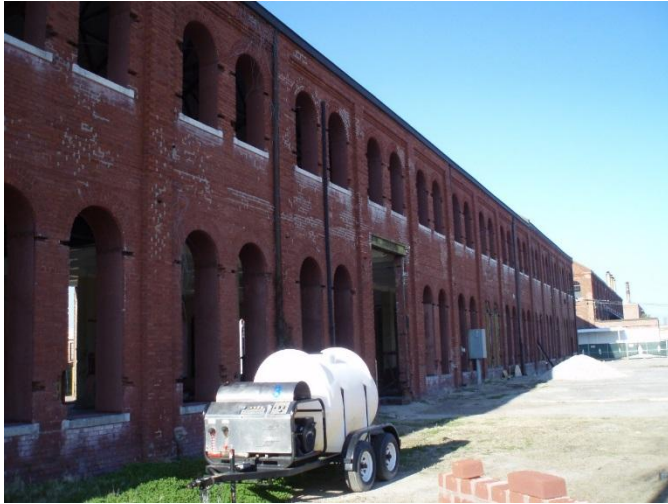
# Mortar – Parris Island Building 11 (1897)

Oxidized Mortar	Oxidized Sand
SiO <sub>2</sub>	%	83.16	95.72
Al <sub>2</sub> O <sub>3</sub>	%	1.87	1.757
Na <sub>2</sub> O	%	0.3	0.3
K <sub>2</sub> O	%	0.2582	0.2677
MgO	%	3.572	0.1
CaO	%	7.498	0
Fe <sub>2</sub> O <sub>3</sub>	%	2.5824	1.5491
MnO	%	0.1207	0.0388
TiO <sub>2</sub>	%	0.1616	0.1562
P <sub>2</sub> O <sub>5</sub>	%	0.107	0.05

Mortar Composition: Rosendale cement, lime, and sand.

Proportions of C : L : S = 1:2:6

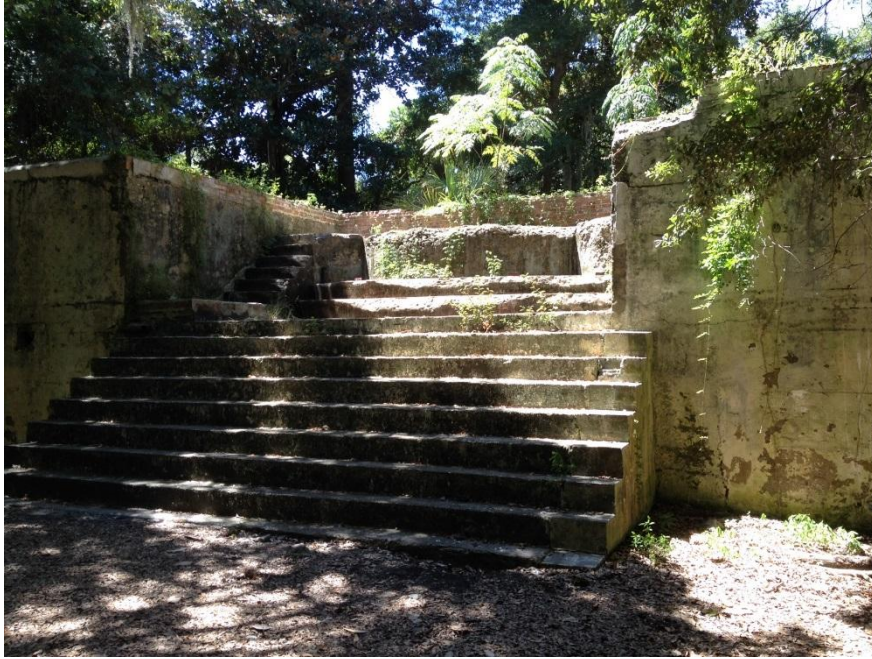
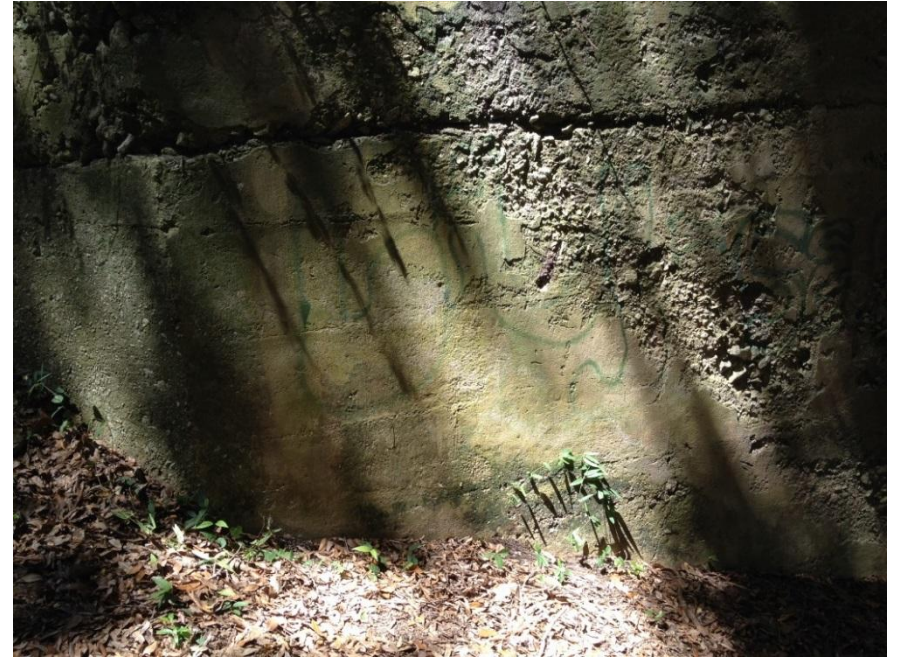
# Concrete – Ft. Fremont (1899)

1 part Rosendale + Portland, 2 parts sand, and  $4\frac{1}{2}$  parts granite.

Relics of Rosendale and Portland were found in the same specimen suggesting they were used simultaneously rather than *necessarily* used by structural purpose.

Bulk density of  $2.21 \text{ g/cm}^3$  or  $138 \text{ lb./ft}^3$  (higher than others – reflects new technology?).

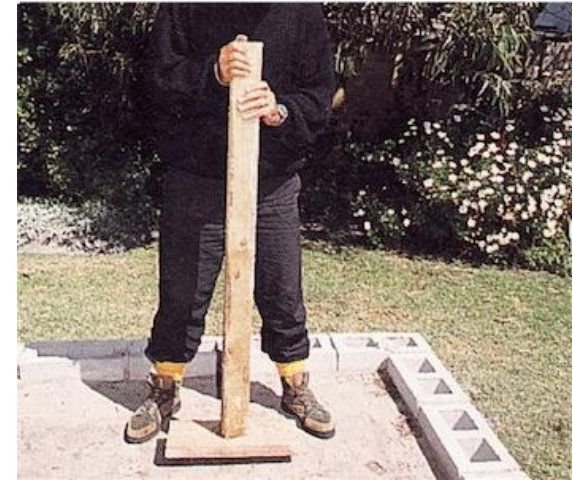
Ramming

Material production was automated by 1898 using steam power. Placement involved shoveling and ramming to consolidate (density) concrete placed behind formwork. Concrete consolidation was rarely optimal.

Semi-automated by 1898. Incomplete consolidation is frequently noted.

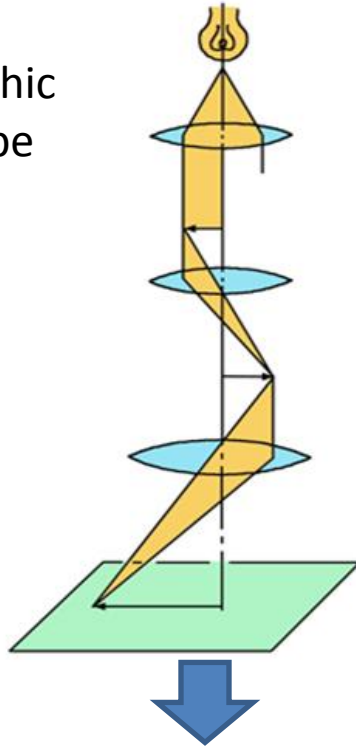
Ft. Fremont

Petrographic  
Microscope  
(Optical)
