FORT WASHINGTON

**SOCIETY FOR THE
PRESERVATION OF
HISTORIC CEMENTS**

THE MASONRY WALLS OF FORT WASHINGTON

BY DOUG BOND, PE FOR THE
SOCIETY FOR THE PRESERVATION OF HISTORIC CEMENTS

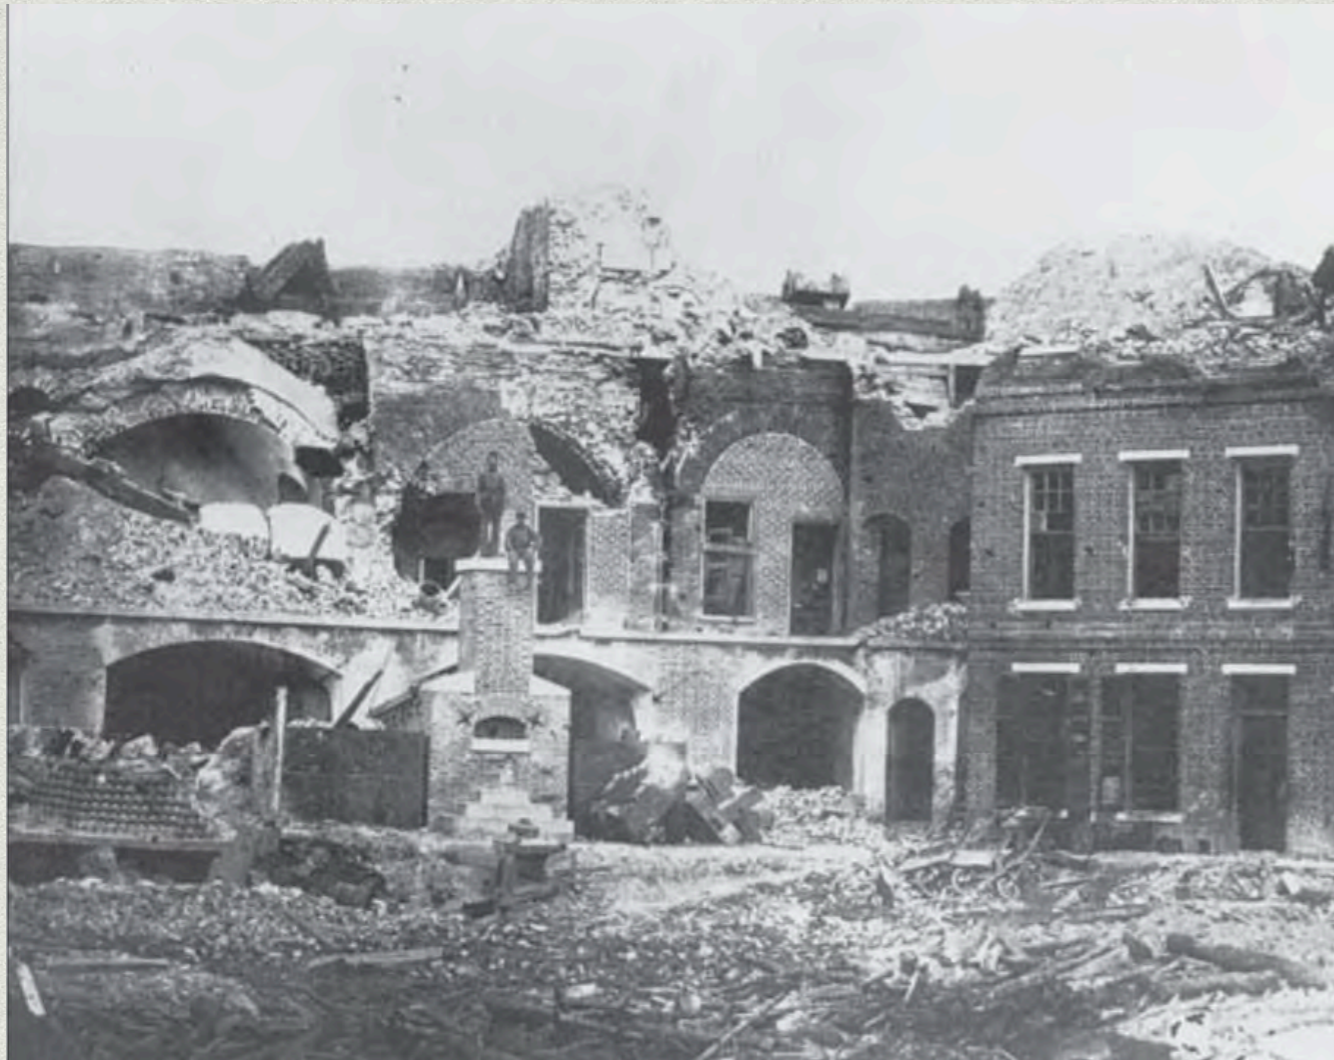
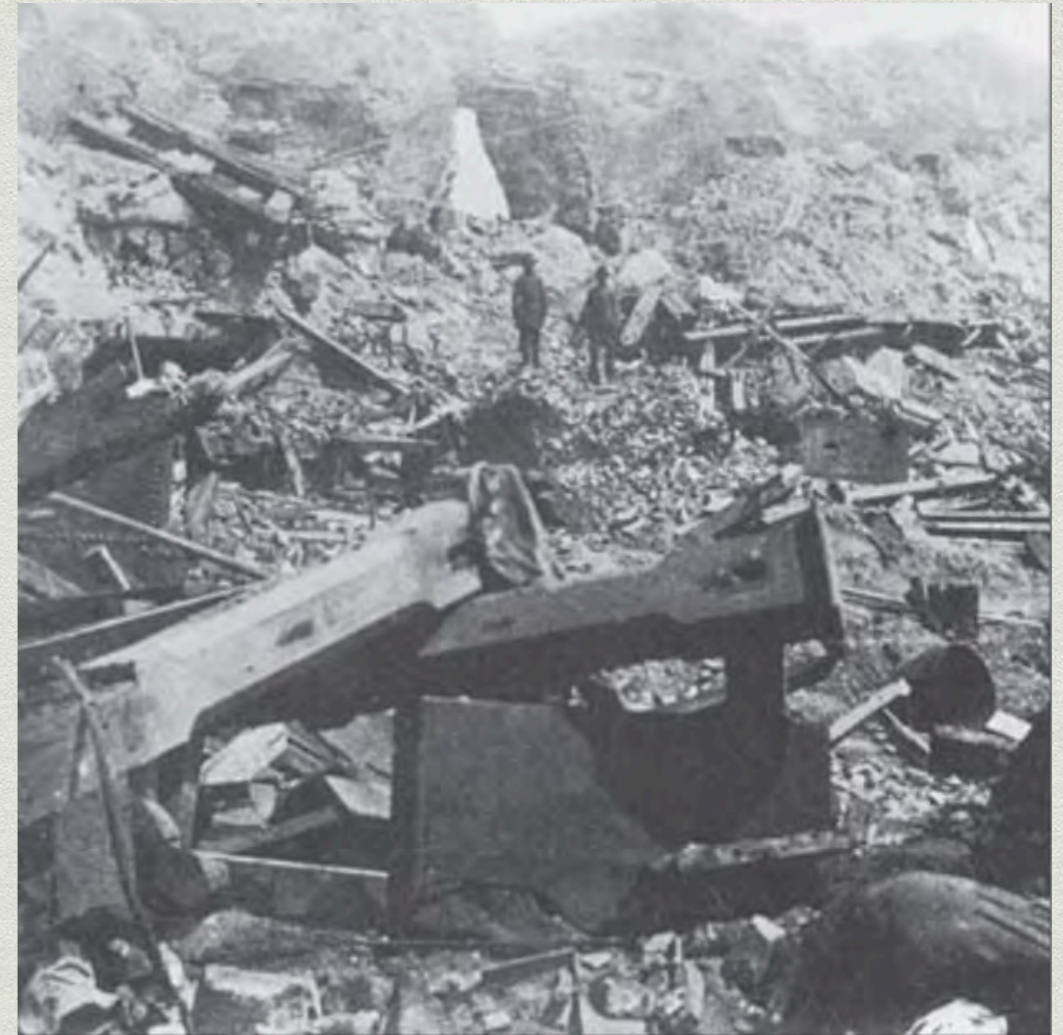
Fort Sumter 1863

Effects of Rifled Artillery and Heavy Mortars

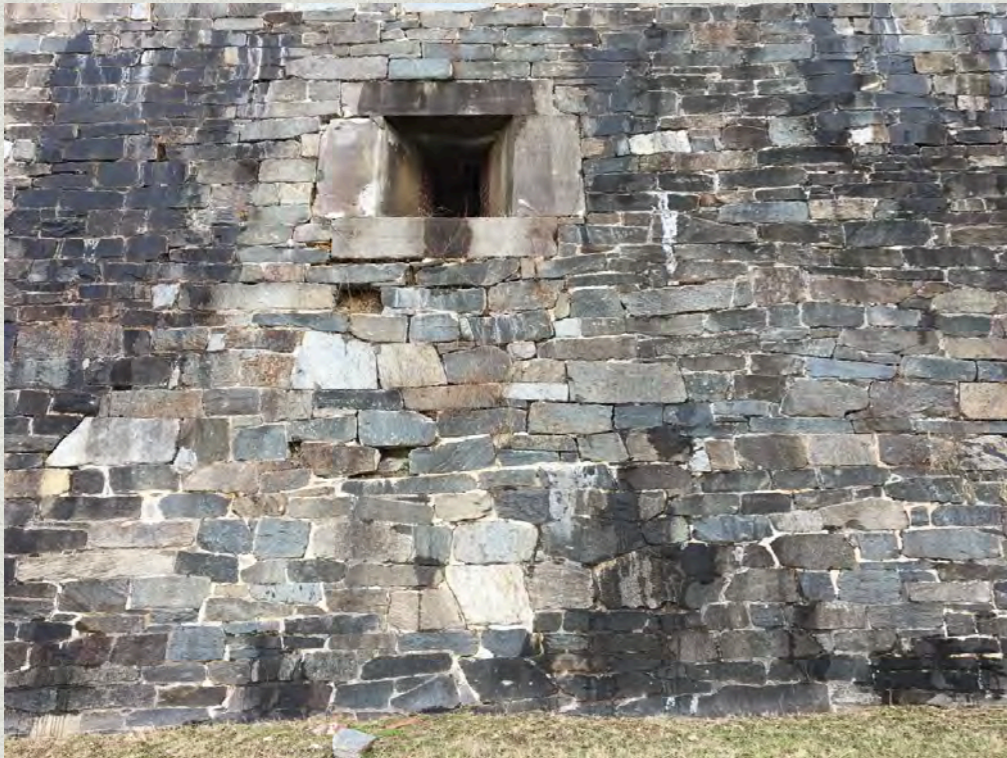
Parapets

- 7'-6" thick
- Flemish Bond
- Vertical
- Outward sloped top
- Stone edges

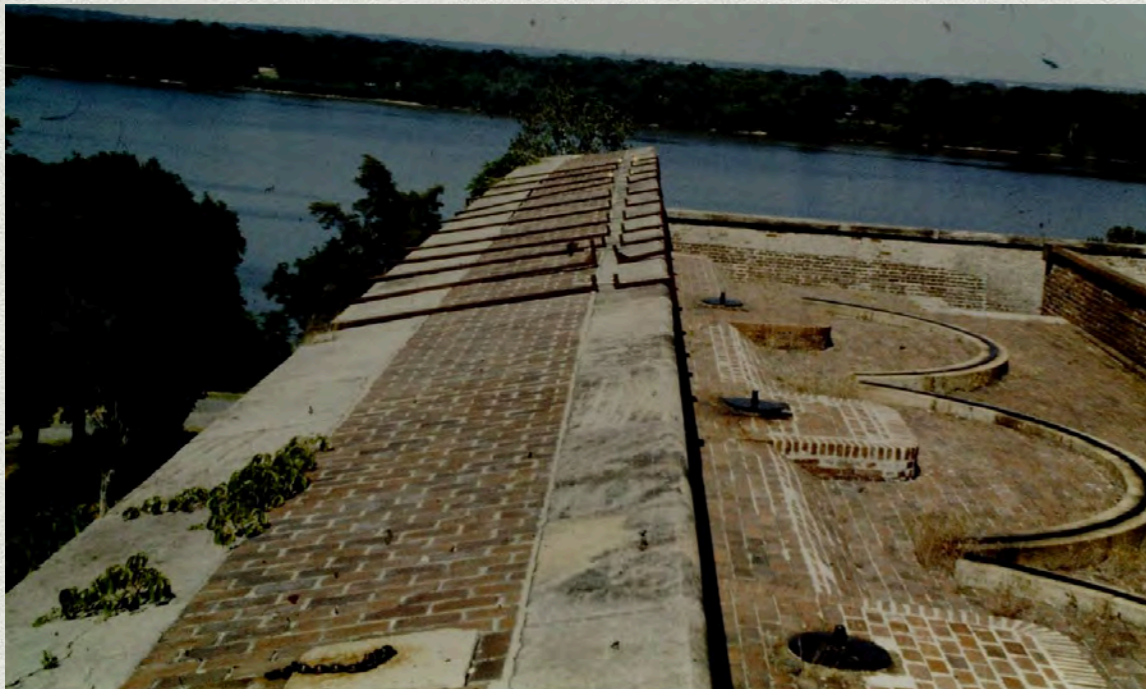
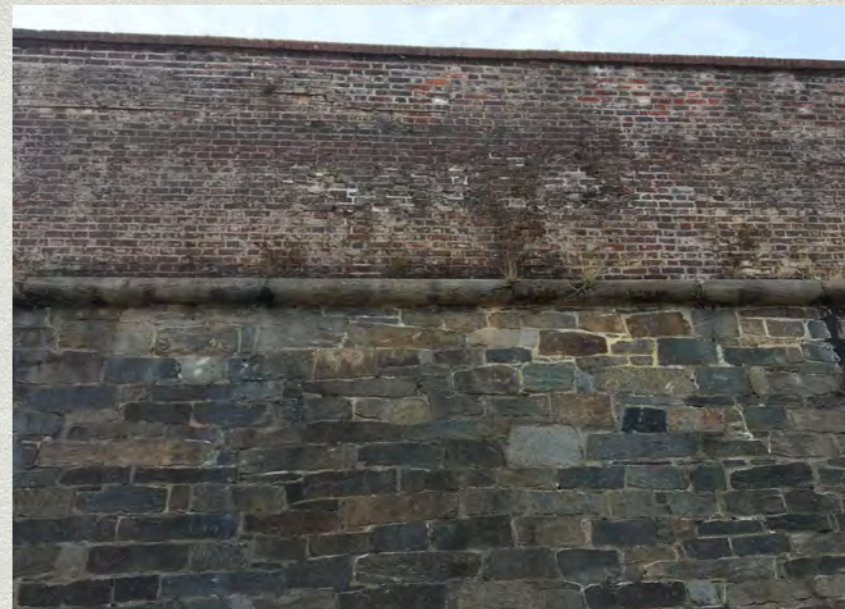
Casemates

- Have Gun ports
- Constructed of Brick on stone foundations
- 15 feet x 22 feet plan
- Brick Vaults radius of 7'-6" rise, 4 ft thick
- Brick work running bond

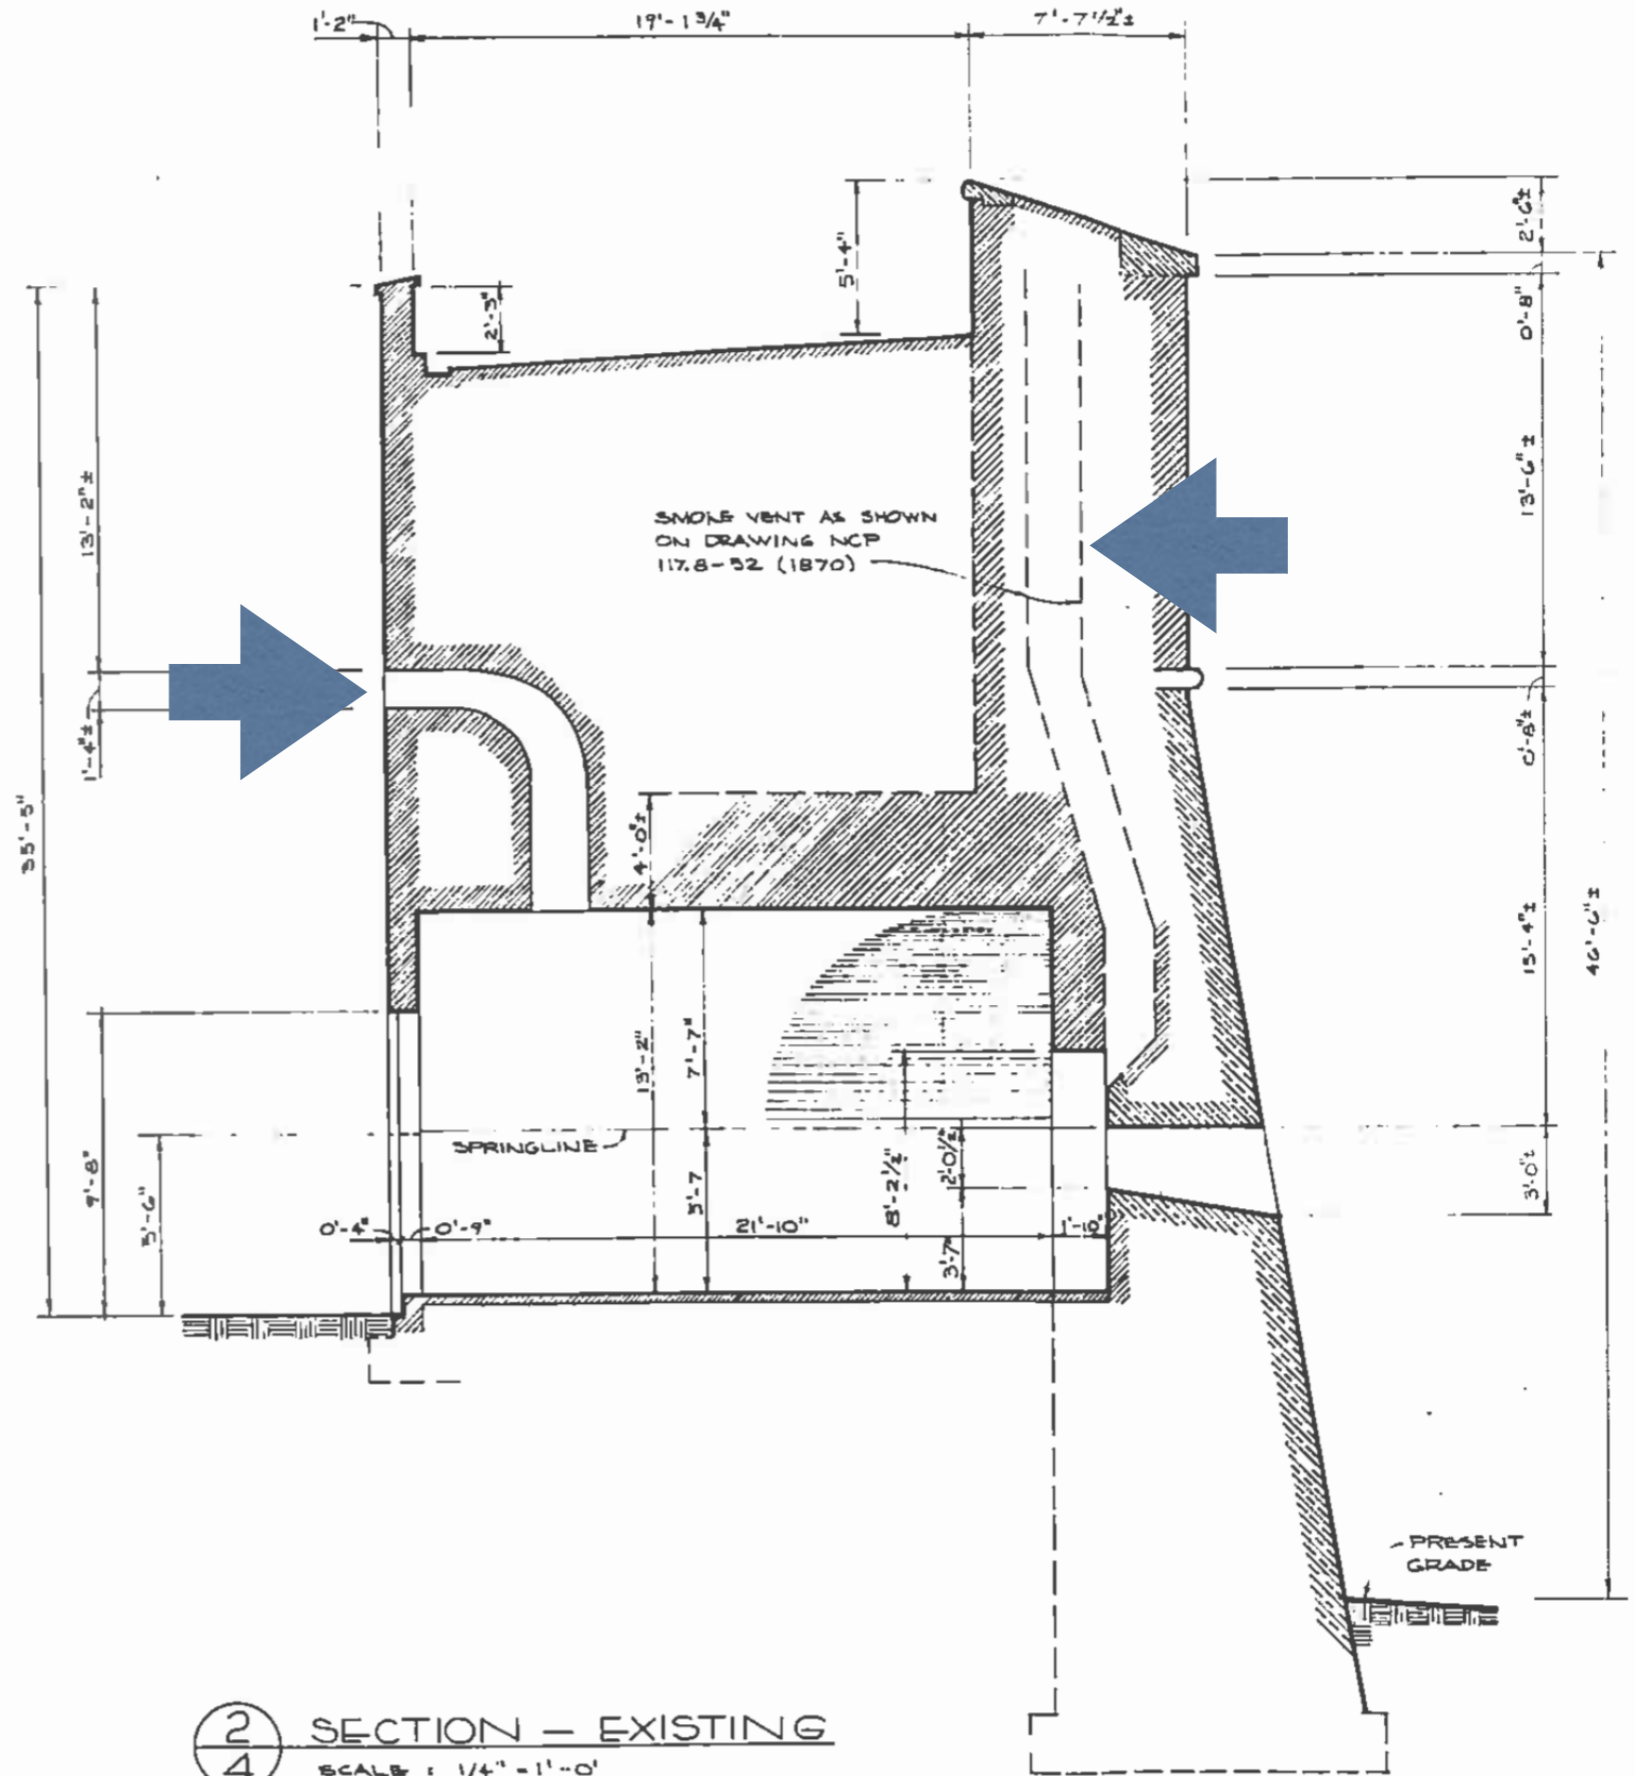
② SECTION — EXISTING
SCALE = 1/4" = 1'-0"

Smoke Vents

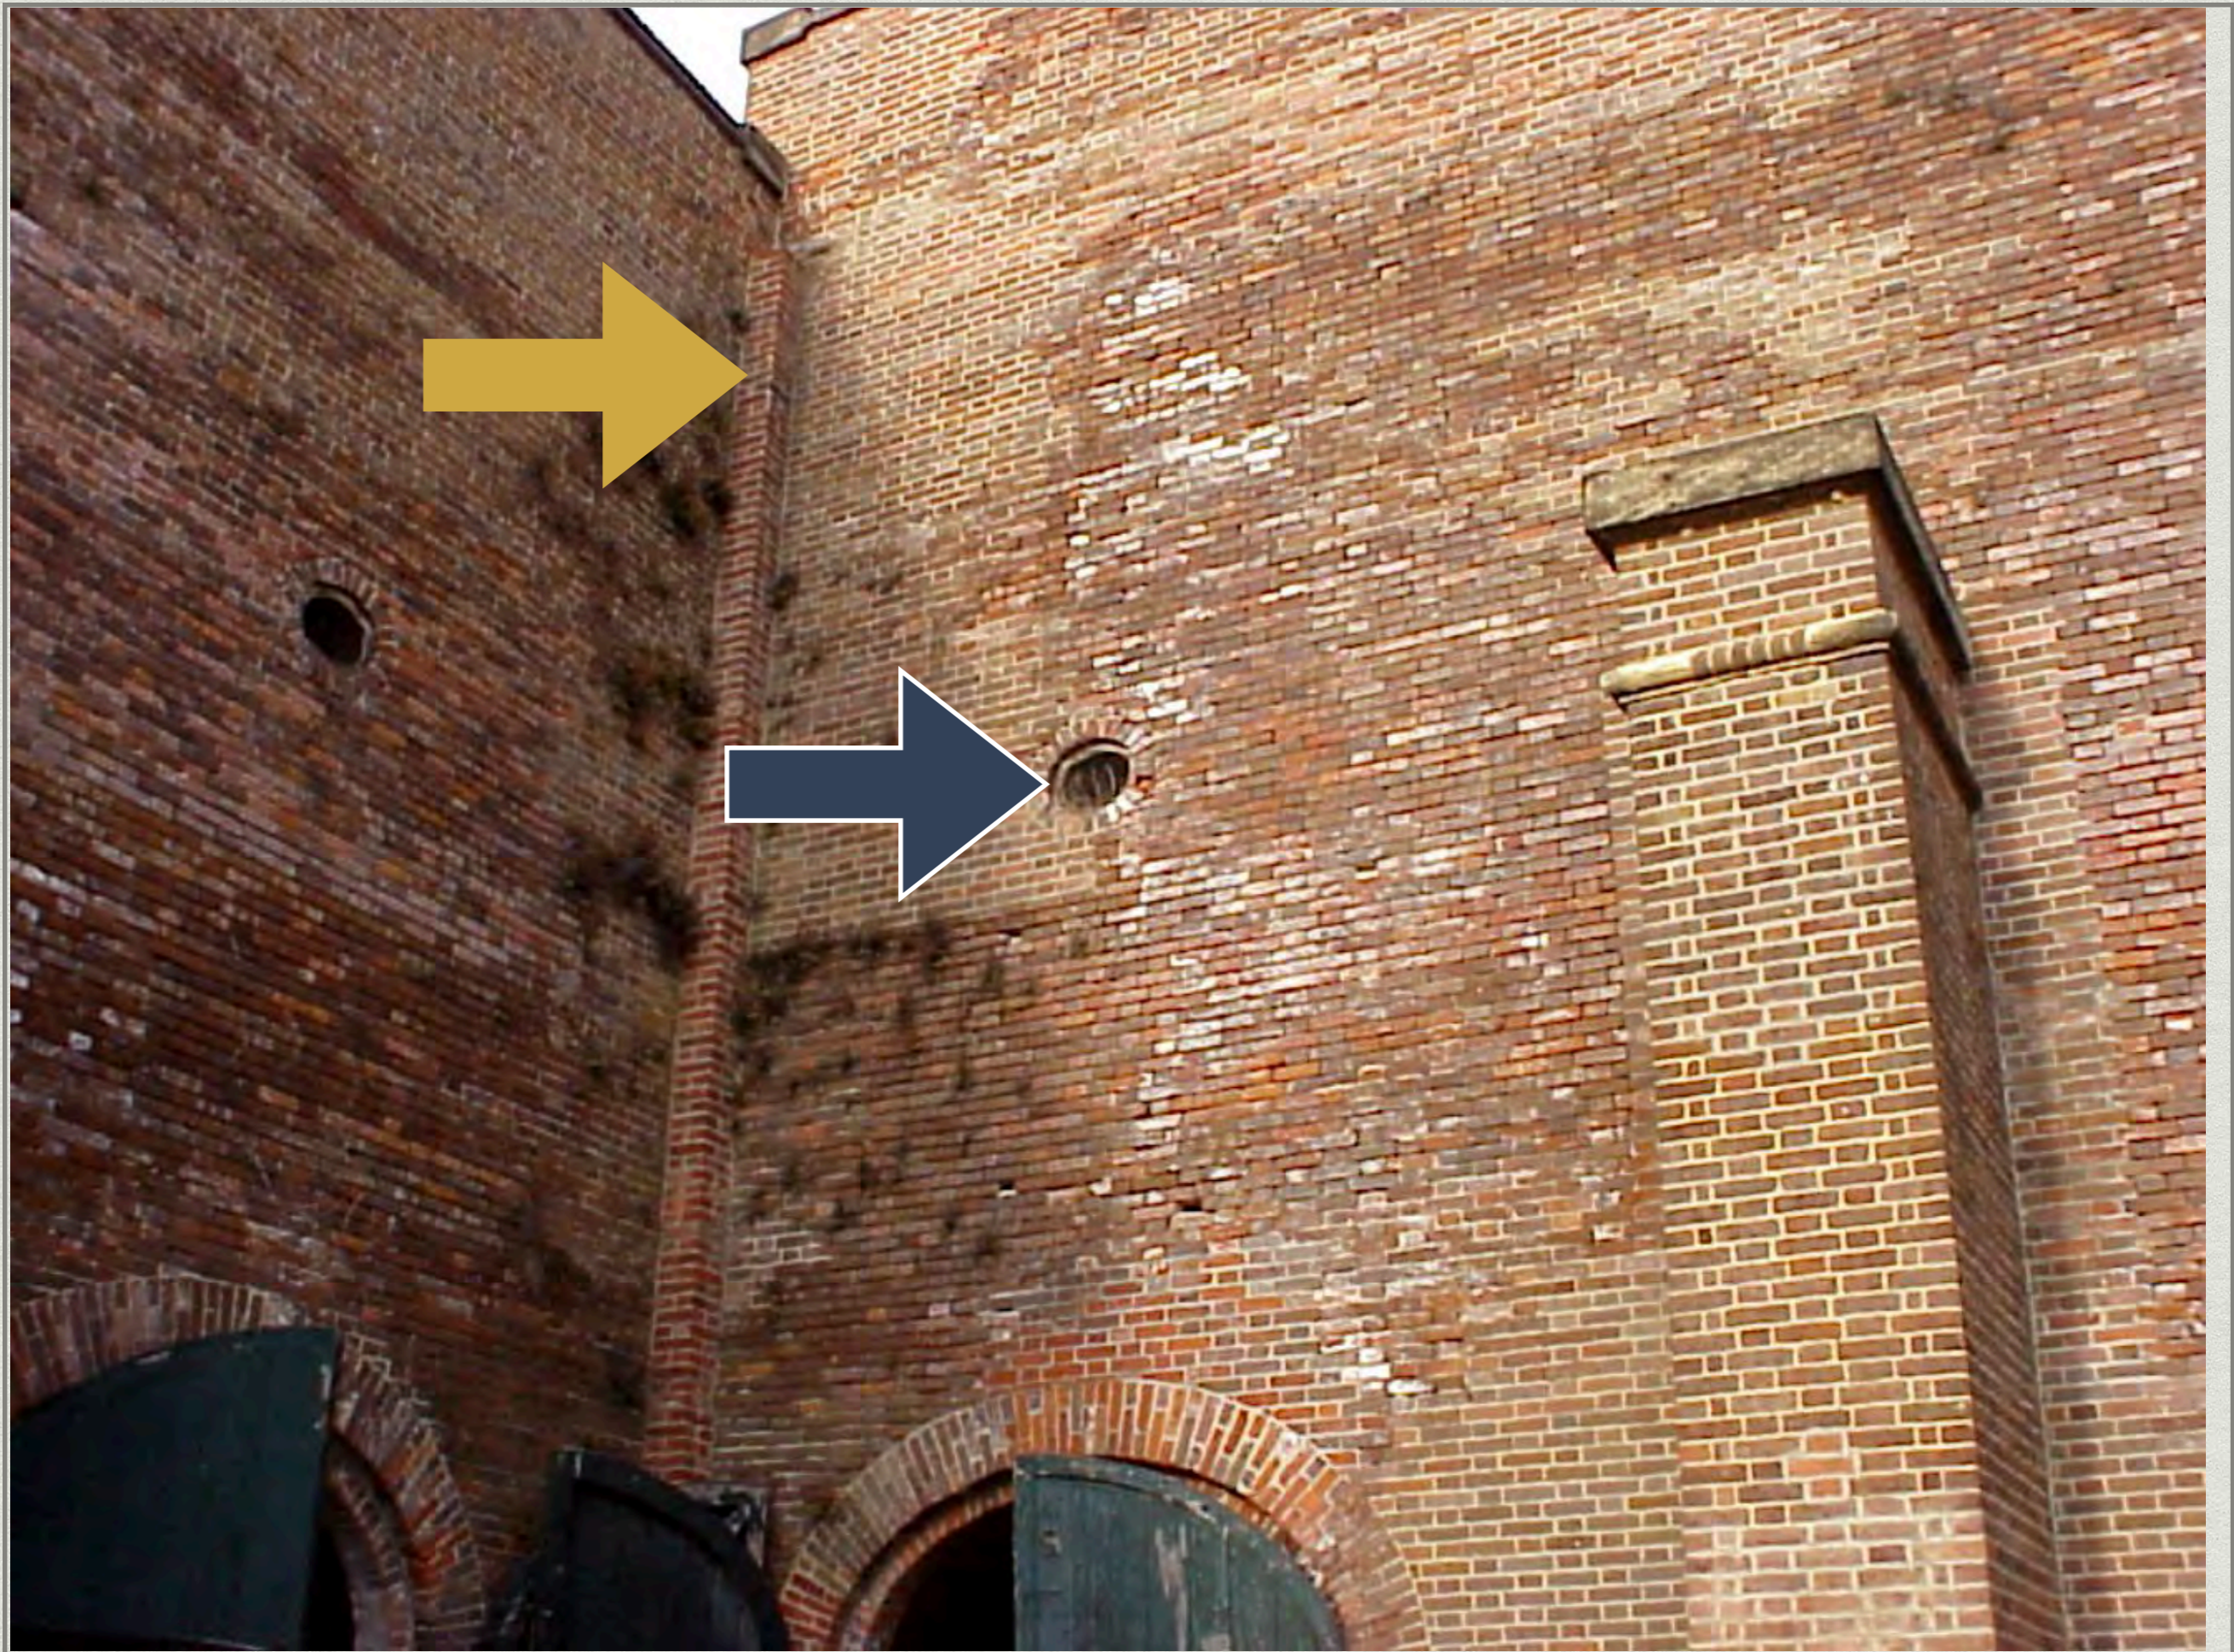
Terreplein

- Upper Gun placements
- Earth fill on casemate brick vaults
- Sloped to drain to brick gutters along interior revetment walls, then to brick downspouts (1846)

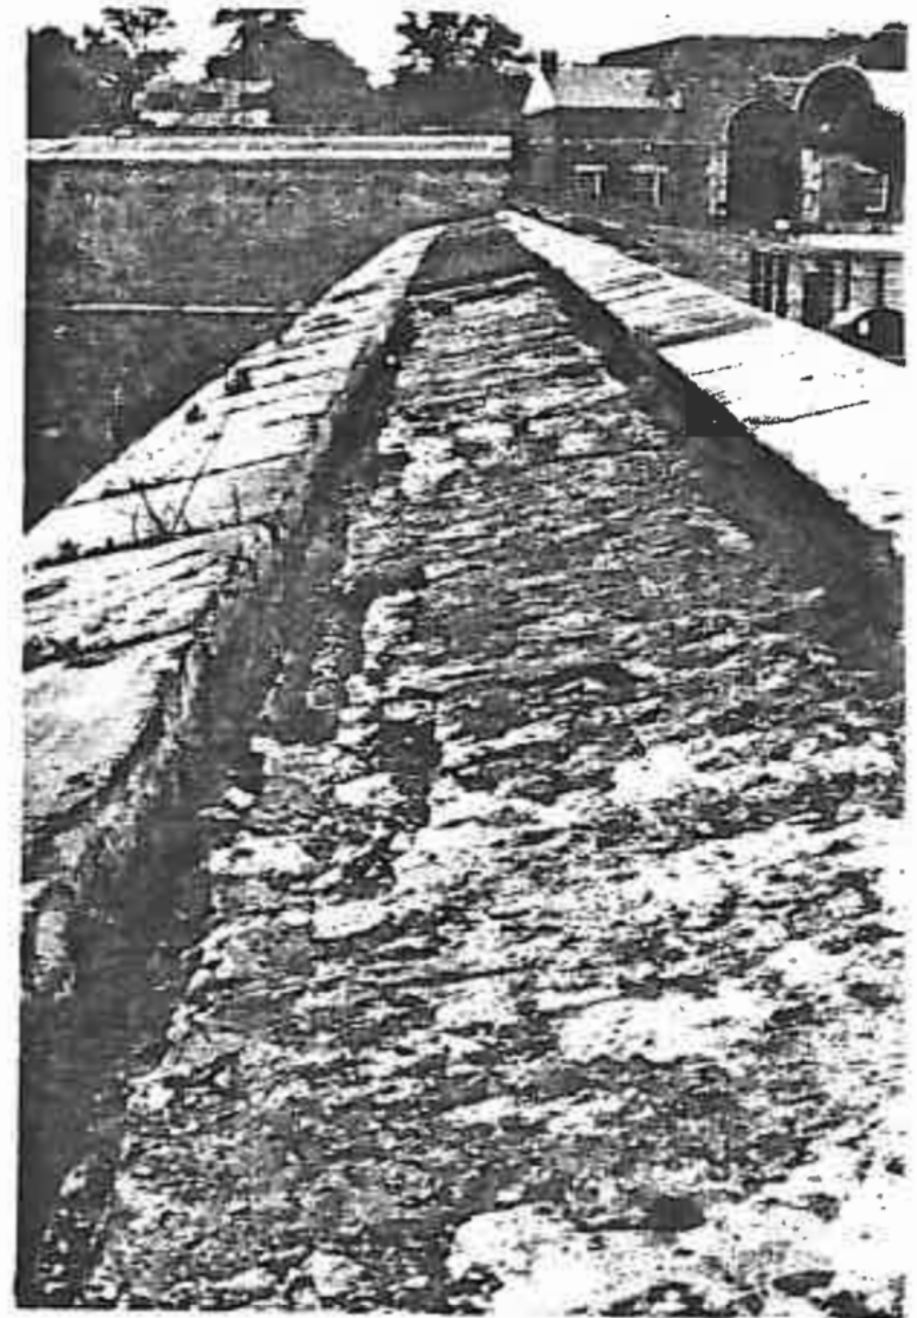
2/8:6/76

- ~~Bulges in the brick~~ noted Northwest Demi-Bastion
- Believed primarily due to Freeze-Thaw
- Repairs made to the brickwork on top of the parapet
- Recommended repairs included removal of vegetation, pointing, and grouting

SUPERIOR SLOPE OF THE PARAPET.
Curtain. Brickwork repair in progress.

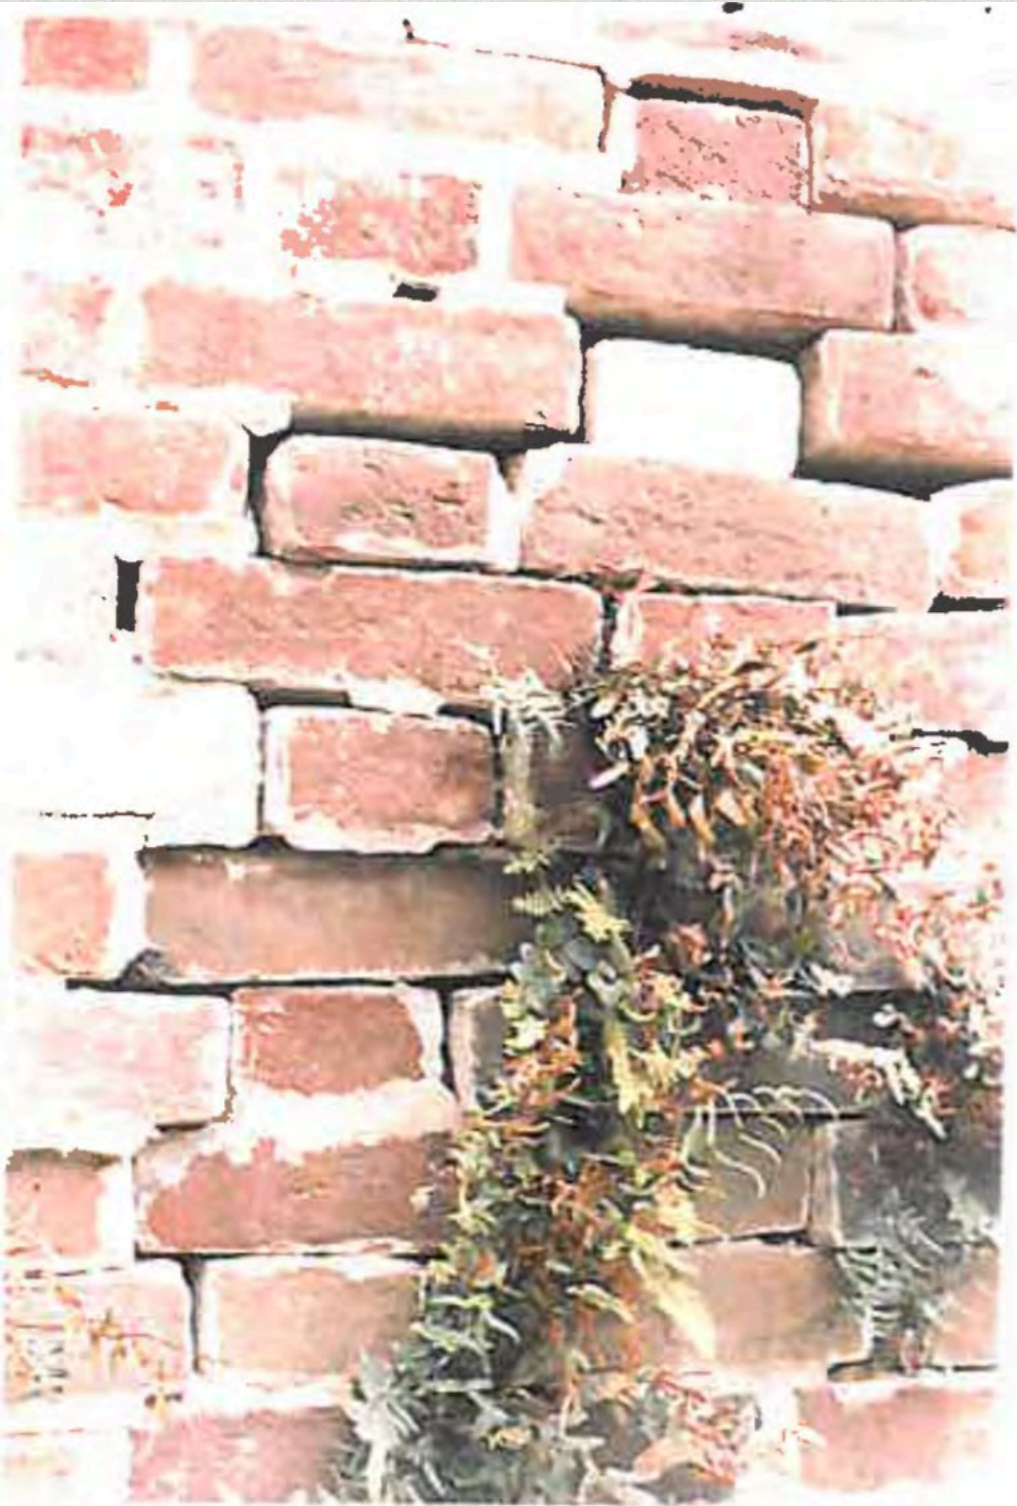
1985 Report

Close up of area of vegetation, the light colored brick & brick below were removed, entire brick structure behind has no sound mortar, only sand with hair remains of original mortar.

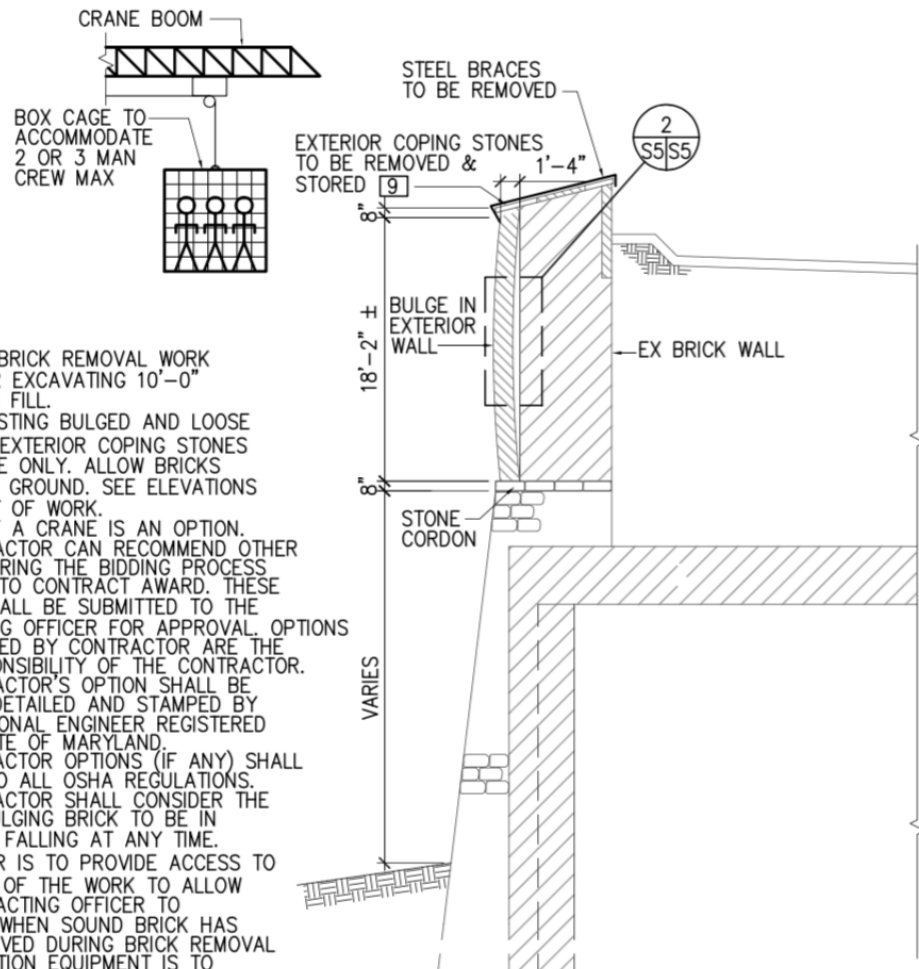
1 EXTERIOR BRICK DEMOLITION PROCEDURE
SCALE: 1/8"=1'-0"

1. START THE BRICK REMOVAL WORK ONLY AFTER EXCAVATING 10'-0" OF EXISTING FILL.
2. REMOVE EXISTING BULGED AND LOOSE BRICK AND EXTERIOR COPING STONES FROM CRANE ONLY. ALLOW BRICKS TO FALL TO GROUND. SEE ELEVATIONS FOR EXTENT OF WORK.

4. CONTRACTOR IS TO PROVIDE ACCESS TO ALL AREAS OF THE WORK TO ALLOW THE CONTRACTING OFFICER TO DETERMINE WHEN SOUND BRICK HAS BEEN ACHIEVED DURING BRICK REMOVAL
