THE MASONRY WALLS OF FORT WASHINGTON

BY DOUG BOND, PE FOR THE
SOCIETY FOR THE PRESERVATION OF HISTORIC CEMENTS

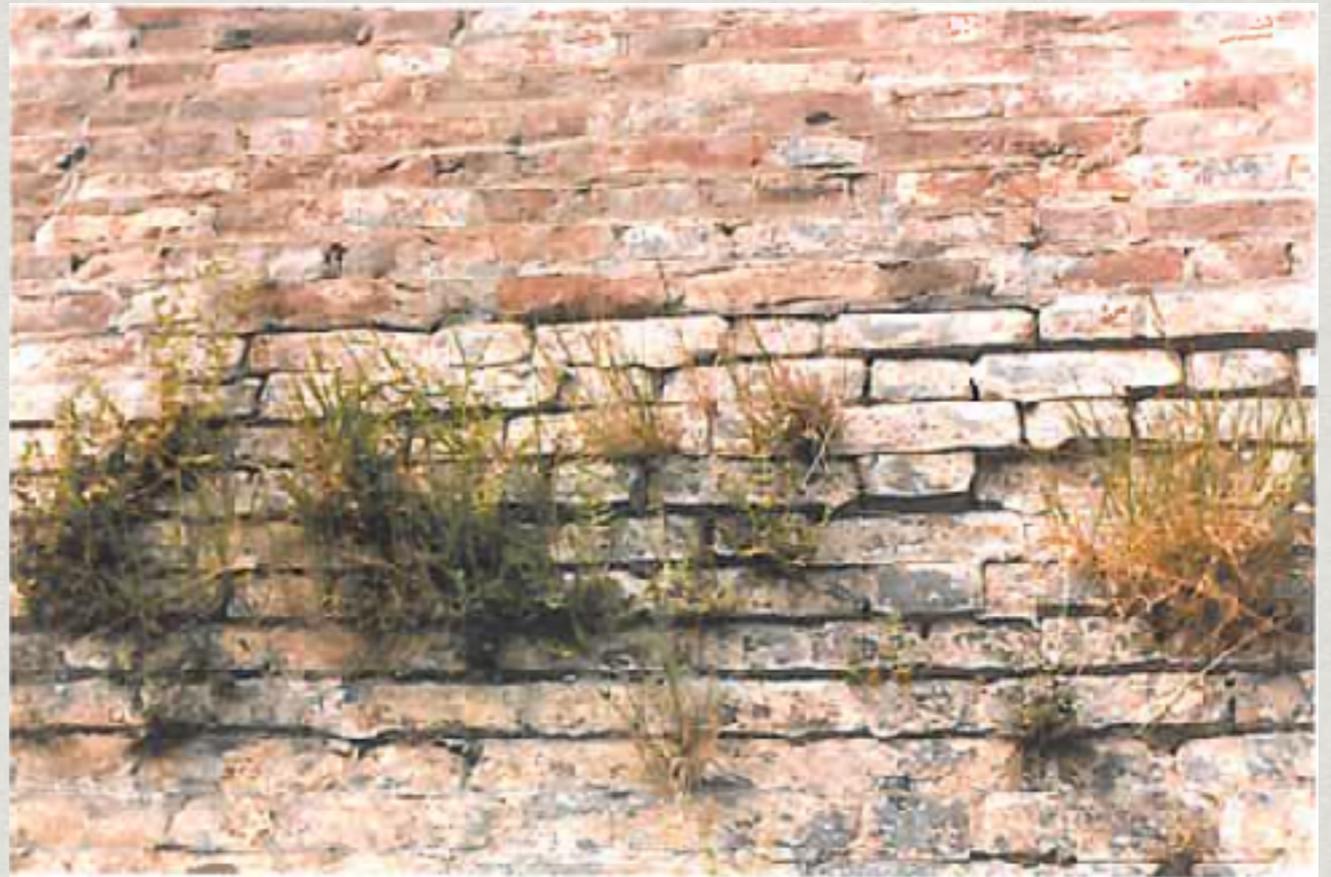
1985 Report

Close up of area of vegetation, the light colored brick & brick below were removed, entire brick structure behind has no sound mortar, only sand with hair remains of original mortar.
